POLYCHLORINATED BIPHENYLS (PCBs):
A NEW HAZARD FOR HISTORIC BUILDINGS

Submitted in partial fulfillment of the requirement for the degree
Master of Science in Historic Preservation
Graduate School of Architecture, Planning and Preservation • Columbia University
(May 2013)

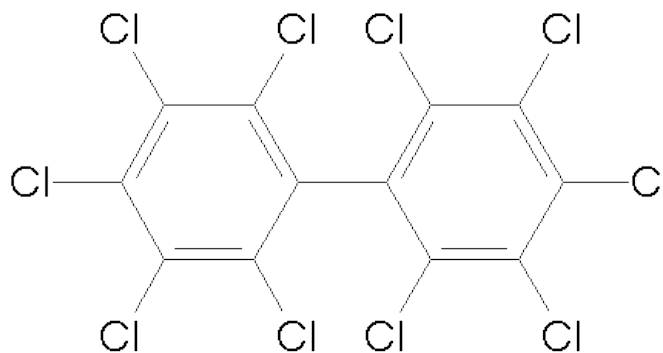
Figure 2.1: PCB Structure

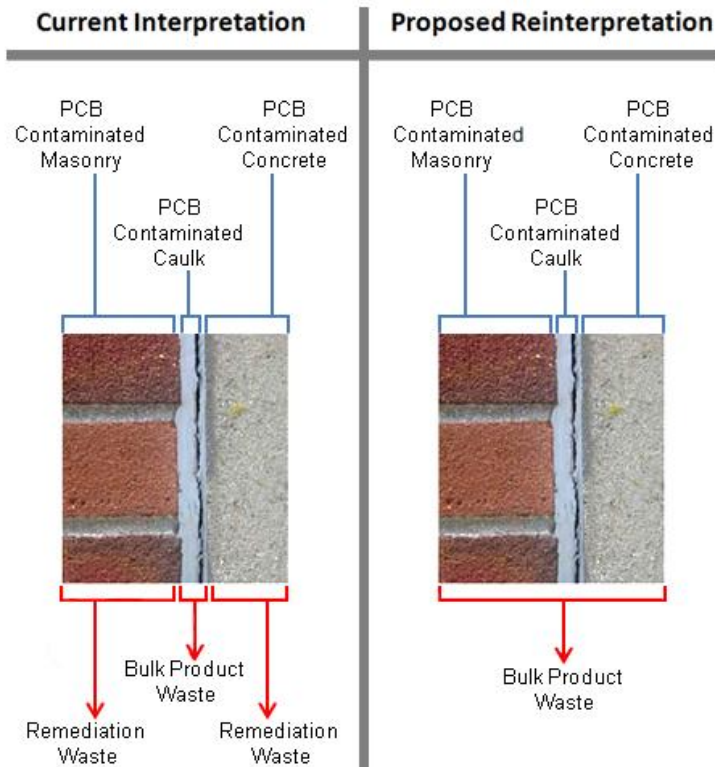
Figure 5.1: Reinterpretation of Bulk vs. remediation waste.
<http://www.epa.gov/osw/hazard/tsd/pcbs/pubs/caulk/reinterpret.htm>

PCB containing materials are disposed of based on their classification as either bulk product waste or remediation waste. Federal regulations for disposal may contrast those of state or local legislation so it is important to check both before choosing a method. For federal regulations three options for bulk waste disposal are found under 40 CFR 761.62.⁶¹ "The performance-based option allows for disposal of *PCB* bulk product waste in a TSCA incinerator, a TSCA chemical waste landfill, a RCRA hazardous waste landfill, under a TSCA approved alternate disposal method, under the TSCA regulated decontamination procedures; or in a facility with a coordinated approval issued under TSCA. Disposal under this option does not require unnecessary approval from the EPA."⁶² In some states, PCB caulk may be disposed of in a regular solid waste landfill without approval. The final option is a risk-based option which is case dependent and requires approval from the EPA.

Because remediation waste has a lower concentration of PCBs than bulk waste, the risk to the environment is less severe. There are also three disposal methods for remediation waste found under 40 CFR 761.61. "The self-implementing option links cleanup levels with the expected occupancy rates of the area or building where the contaminated materials are present. The disposal requirements for the self-implementing regulatory option vary based, among other things, on the type of contaminated material and concentration of PCBs in the materials."⁶³ The EPA should be notified, but they do not have to grant approval. The remediation waste may also use the performance-based option that "allows for disposal of the contaminated materials in either a TSCA chemical waste landfill or TSCA incinerator, through a TSCA approved alternate disposal method, under the TSCA regulated decontamination procedures, or in a facility with a coordinated approval issued under TSCA." The last option is again a risk-based cleanup and disposal used on a case by case basis with approval from the EPA.

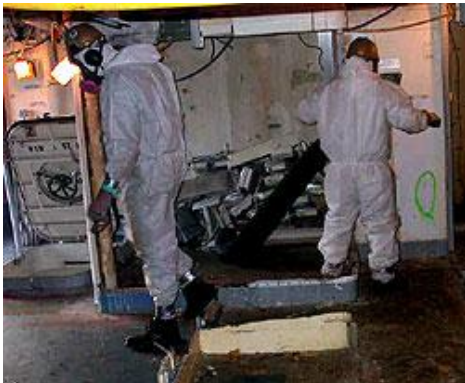
Figure 4.2 "Workers with respirators, ear muffs and other personal protective equipment (PPE)."

Some degree of protective measures will be required to protect workers, occupants and third parties. The level of personal protective equipment (PPE) required is dictated by the Occupational Safety and Health Administration (OSHA). OSHA was formed under the Occupational Safety and Health Act of 1970 to create safe working environments by making and enforcing standards and by providing training and education.⁷⁰ OSHA determines when PPE is required and to what degree based on permissible exposure limits (PEL) which is calculated based on a concentration over an 8-hour time frame. The equipment needed depends on the authorized plan, but includes chemical-resistant gloves, Tyvec coveralls, goggles, and a respirator.⁷¹ With mechanized tools, additional respirators may be necessary because of the increased number of dust particles in the air. To protect occupants and third parties from dust particles, an enclosed containment area with plastic covering and a HEPA filter should be used to control the dust. Additional vacuum attachments can be placed on electromechanical devices.

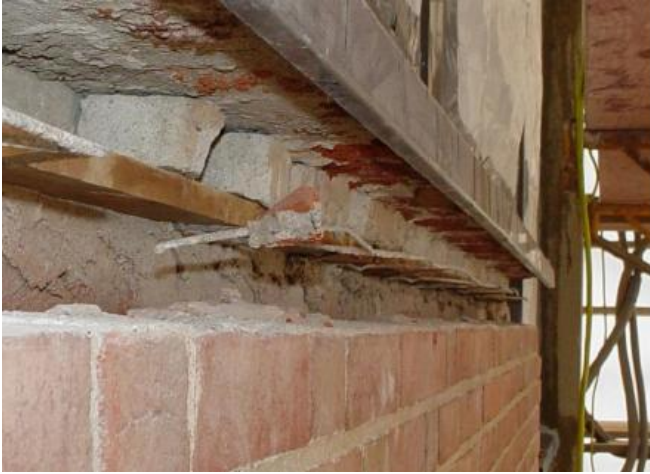
Figure 6.2.4: Westgate Brick Removal
Cambridge, MA
Image Courtesy of MIT, 2007

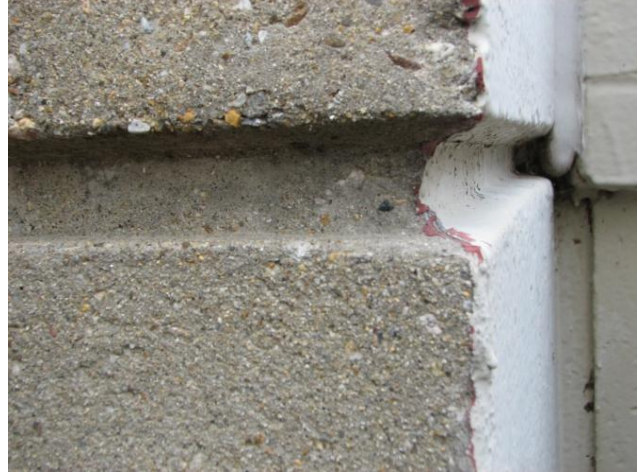
Figure 6.2.5: Westgate Encapsulation Detail
Cambridge, MA
Photographed by Emily Sinitski, 2013

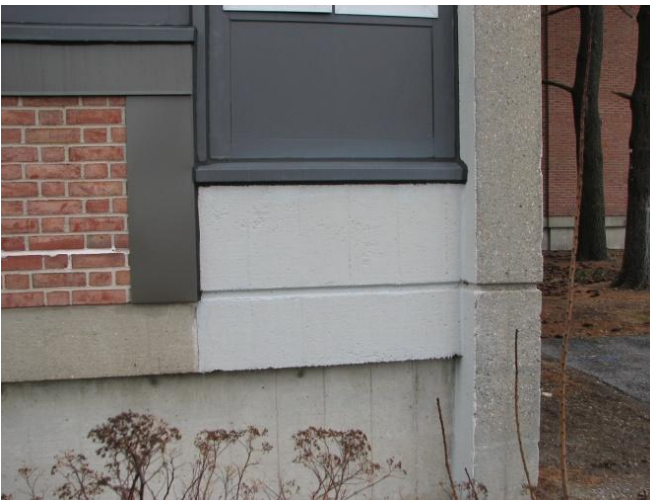
Figure 6.2.6: Westgate Encapsulation Detail
Cambridge, MA
Photographed by Emily Sinitski, 2013

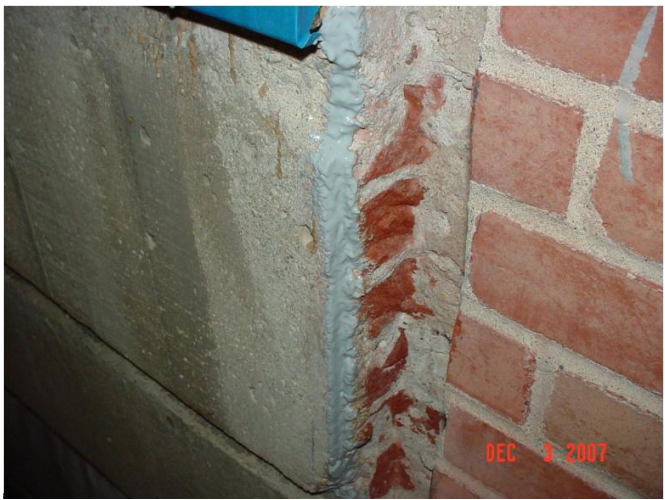
Figure 6.2.7: Westgate Silicone Encapsulation Detail
Cambridge, MA
Image Courtesy of MIT, 2007
