PRESERVATION, MANAGEMENT, AND STABILIZATION
APPROACHES AT FRANK LLOYD WRIGHT'S TALIESIN
AN ANALYSIS OF THE EVOLUTION OF INTERVENTION STRATEGIES

Allison Semrad

Submitted in partial fulfillment of the requirements for the degree
Master of Science in Historic Preservation

Columbia University
(May 2017)

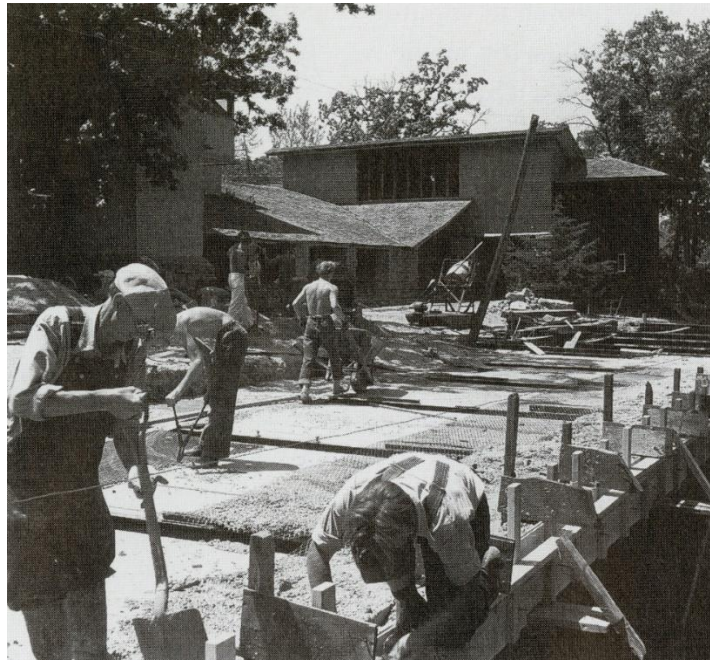
Figure 7. Construction of the Lower Court, 1930s, from Curtis Besinger's Working with Mr. Wright,

Additionally, the site is materially difficult to preserve. Taliesin's buildings are located in a harsh climate with wet, freezing, windy winters and hot, humid, stormy summers (Figure 5). In terms of terrain, the building of Taliesin are situated in a rolling landscape. Wright's residence and studio is built not onto the top of a hill, but instead in into the brow of the hill, creating an inherently precarious structure (Figure 6). Through more than half century, Taliesin was an experimental site, an idea reflected in the site's original construction and tradition of modification. The buildings evolved and changed for half a century and apprentices were often responsible for construction projects and alterations. While these enthusiastic, but often untrained, laborers are responsible for Wright's daring expressions and a significant work of architecture, they did not construct the building to contemporaneous codes, let alone modern ones (Figure 7).

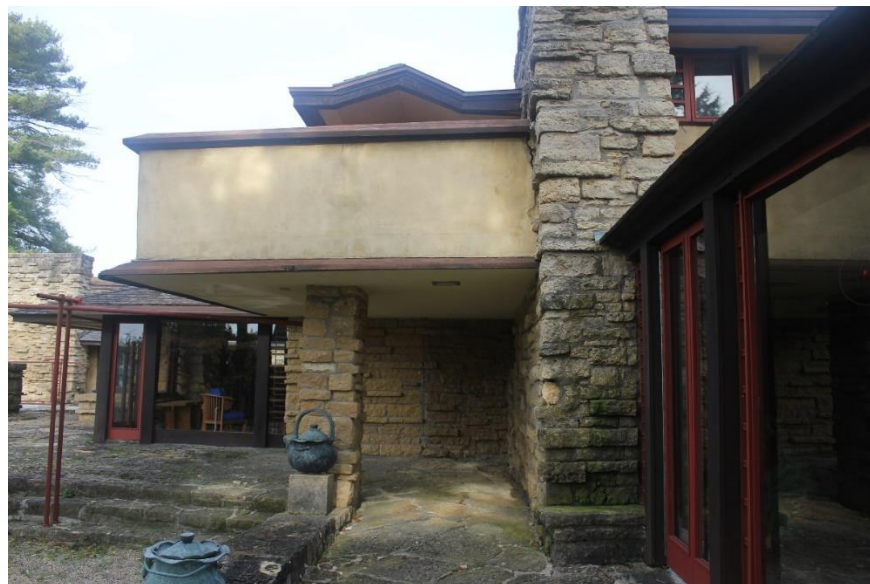
Figure 14. Taliesin Courtyard Detail, looking northeast. Note the common material, found throughout the site, including stone patios, limestone retaining walls and piers, large plate glass windows, wood trim, wood moldings framing cantilevered terraces, light-yellow plaster and stucco, red wood-trim details, photo by author, 2016.

Similar to Hillside School and Tan-y-Deri, each version of the Taliesin residence employed locally-sourced materials, albeit often in more inventive and daring ways. As previously discussed, Wright built the structure not at the *top* of the hill, but into the *side* of it, relying on limestone retaining walls and structural piers for support. Masonry walls throughout the site were constructed with lime mortar, typical for the time. Taliesin's relatively unconventional limestone foundations, sometimes called "welsh foundations," have fared well over time, yet the piers were often originally structurally inadequate to support Taliesin's bold, expansive structure especially after countless expansion and modification campaigns. This, however, never seemed to worry Wright, who operated on a premise that the building was ephemeral, and could be modified and rebuilt any number of times to respond to changing needs. It's also important to note that, while Taliesin is often divided into three eras – I, II, and III –the fires did not create clean breaks or necessitate entirely new buildings, as some areas of the building, such as Wright's studio, were never damaged by fire. Accordingly, sections of Taliesin III, especially masonry pieces, date back to earlier iterations of the building. Every iteration of Taliesin employed the same material palette; limestone foundations, piers, and walls in combination with wood joist floors, (sometimes paved with stone), slab-on-grade floors, wood stud walls, wood frame roofs with cedar shingles, plate glass windows and doors (sometimes meeting at mitered-corner joints), lath, plaster, and stucco (Figure 14). Additionally, the building features repeating elements of horizontal wood trim, added to parapet caps and at the baseboards of the many interior and exterior walls.

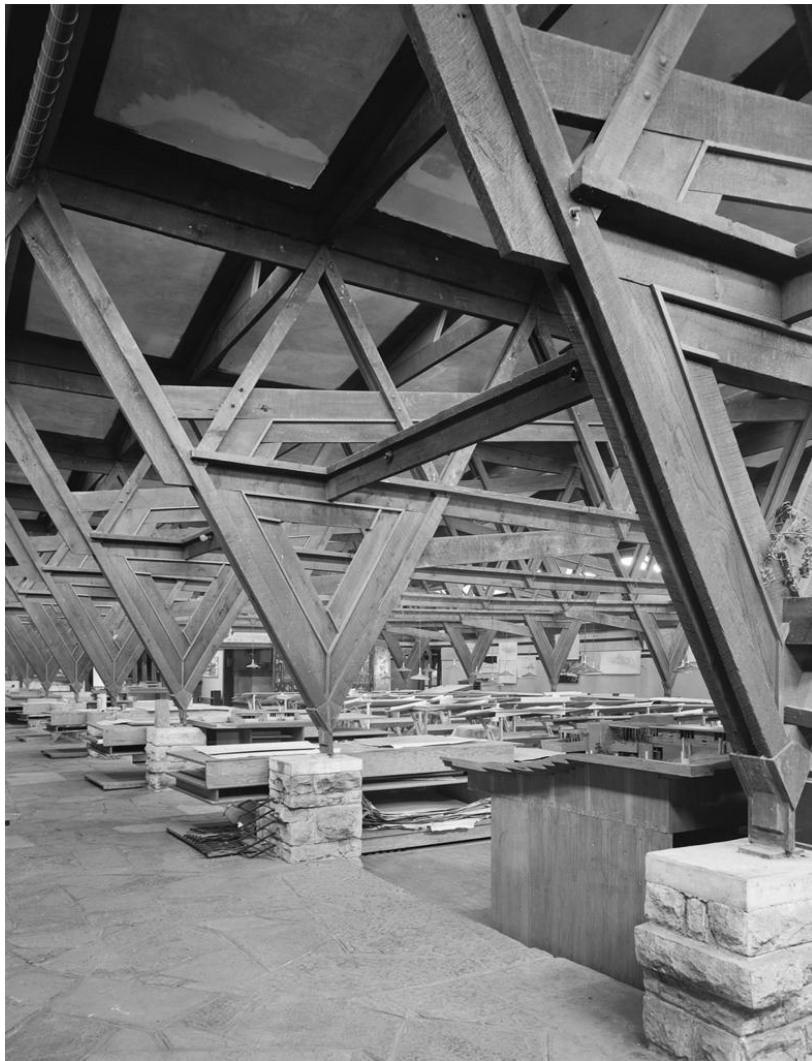
Figure 16. Hillside Drafting Room, circa 1940s, note the elaborate roof trusses supporting the wide span. Photograph by Ezra Stoller, photo courtesy Frank Lloyd Wright Foundation Archive, Esto Collection via Artstor.

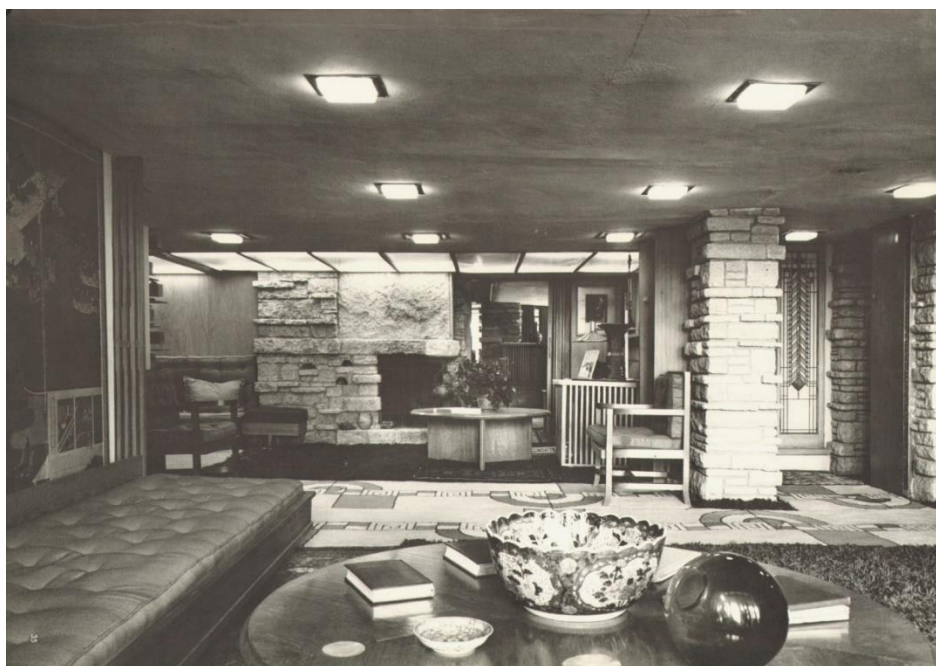
Figure 22. *Taliesin Interior, c. 1980s, note the addition of fluorescent lights in the room in the distance (pink loggia), from the Maynard Parker Collection, courtesy of TPI and the Huntington Library.*

Between 1959 and 1985, Mrs. Wright made a number of interior modifications to the Wisconsin house, including the addition of fluorescent lights, reconfiguration of the floorplan, and change in furniture and wall finishes. Photos from the 1960s through the 1980s document a house that was largely different than the one Wright himself occupied (Figure 22). Because construction work at Taliesin was not meticulously documented (especially after

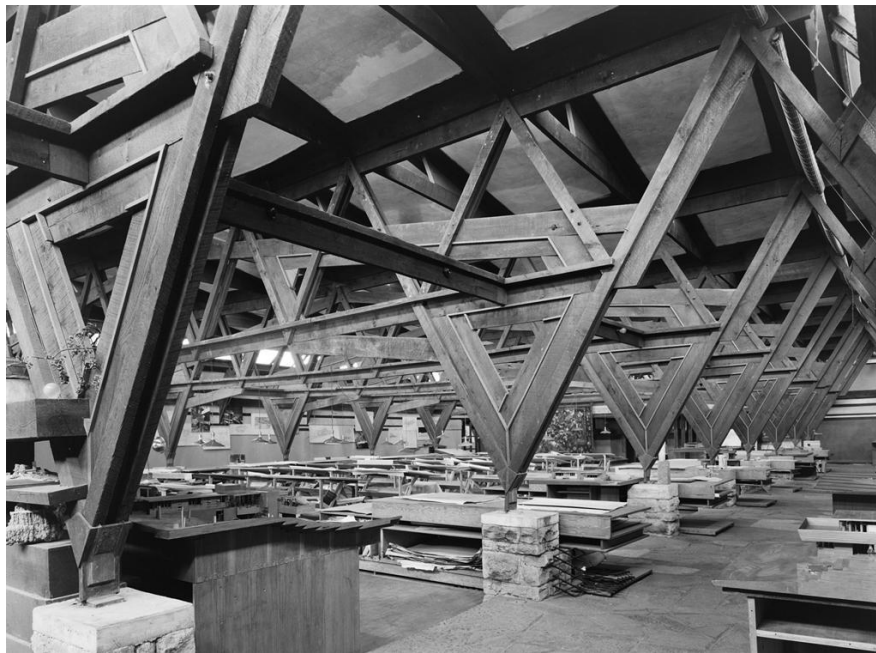
Figure 23. Hillside Drafting Room, historic photograph, circa 1940s. This photo shows the roof trusses, which were eventually stabilized by the addition of steel in the upper chord of the trusses. Correspondence shows that the roof had displayed stability problems since the early 1970s. This project was one of the first interventions funded with state and national funds allocated for "preservation." Photo courtesy of Frank Lloyd Wright Foundation Archives and the Ezra Stoller Archives as Esto, accessed via ArtStor.

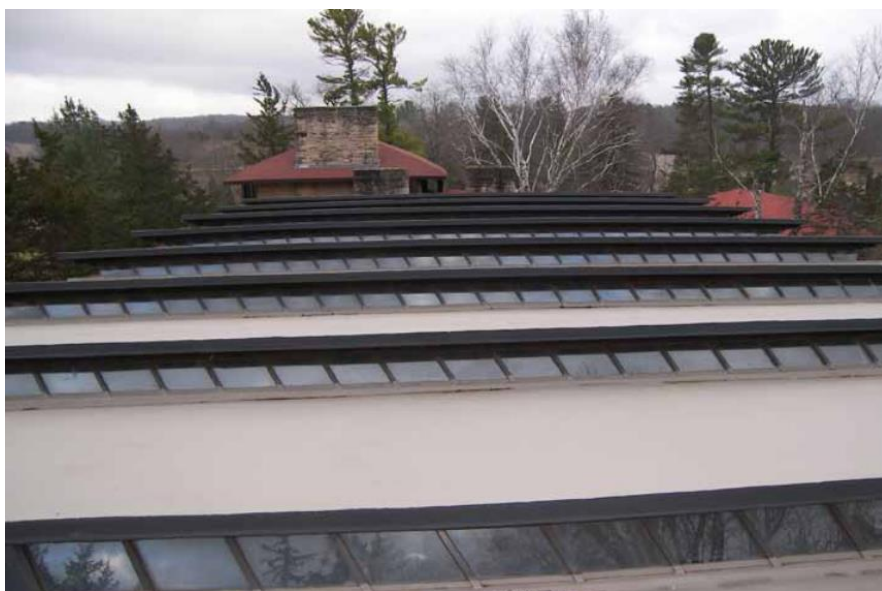
Figure 24. Hillside Drafting Room Roof, looking south, photo taken after 2000. Photo courtesy of TPI.

In a more pragmatic version of narrative, TAA designed a preservation intervention for the drafting room that included the addition of steel plates to the existing wood trusses. Upon engineering analysis, it was decided that the existing trusses were under-designed for the roof as built and should be strengthened for even minimal stability. Even though it altered the original design of the trusses, Wisconsin's SHPO approved the intervention as a way to maintain the space's historic appearance and its safety. The project of 1978 also removed a heavy asphaltic layer that had been applied to the exterior of the sawtooth roof, perhaps around 1970.⁴⁵ (Figure 24).

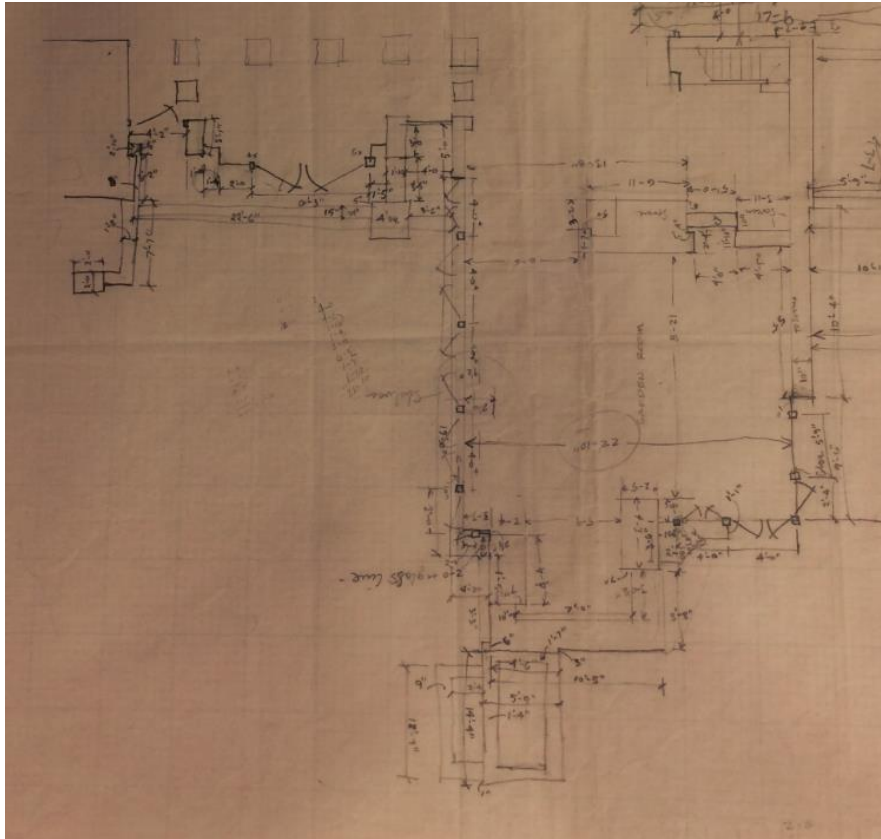
Figure 25. Sample survey sketch, showing documentation efforts of the early 1970s. This sketch includes measured details within the Taliesin residence, image courtesy of the Frank Lloyd Wright Foundation Archive, Avery Library.

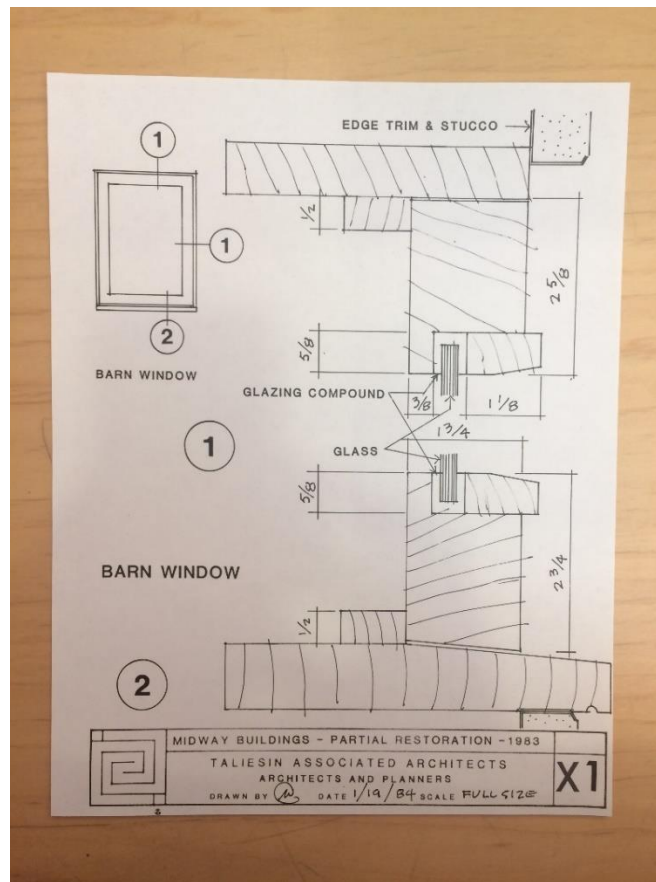
Figure 26. Midway Barn Window Glazing Detail, likely part of the 1980s grant project, note the detailed documentation of conditions and the attention to trim details. Drawings were prepared by Taliesin Associated Architects, indicating that much of the design work happened in-house, and that TAA was responsible for documenting the building and proposing how it should be preserved, image of document from Frank Lloyd Wright Foundation Archive at Avery Library.

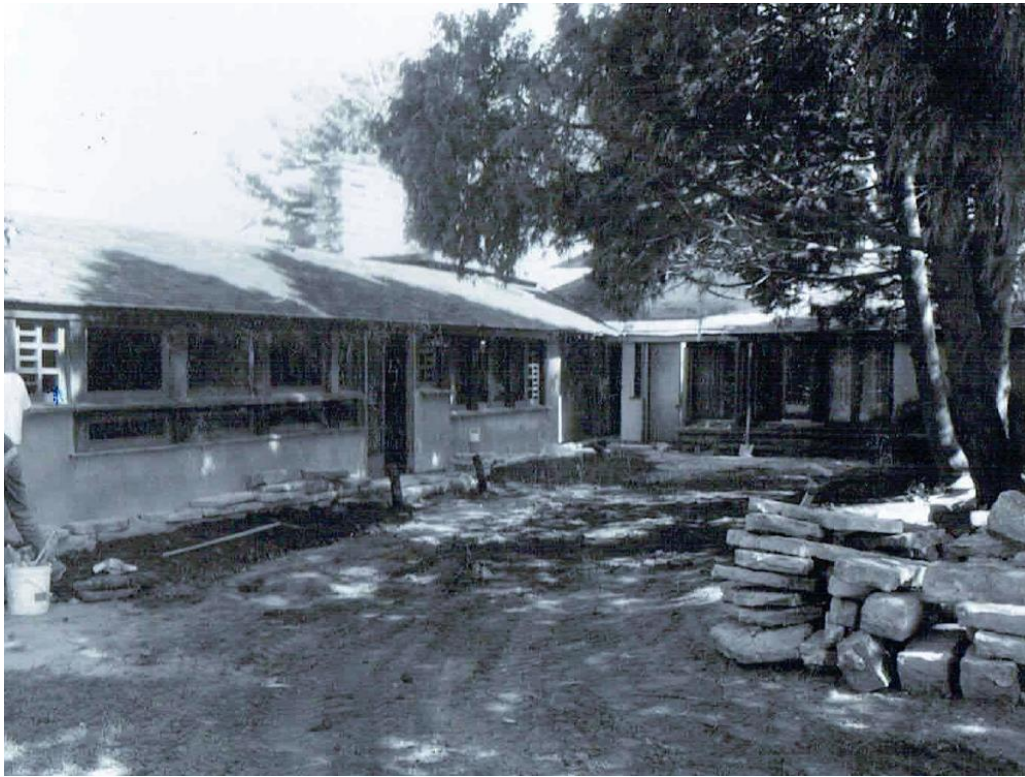
Figure 27. Hill Wing Progress, c. 1990/1991. Excavated/Removed paving visible at the left side of the photo, excavation of area adjacent to the building visible along the left portion of the photograph. Photo courtesy TPI.

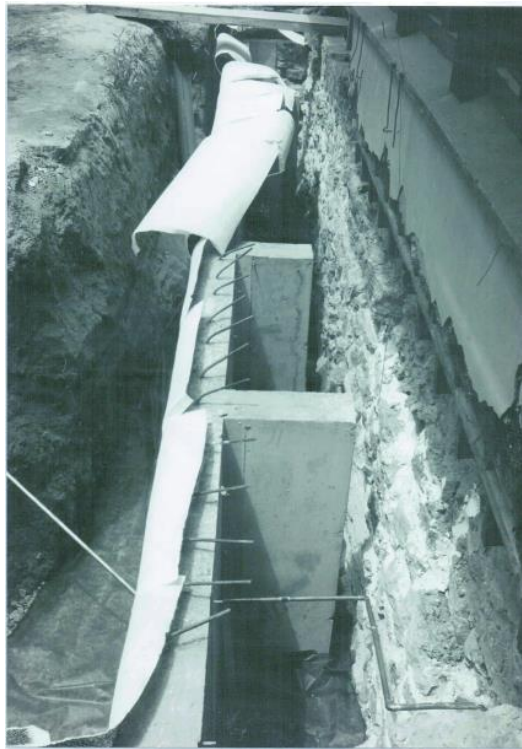
Figure 28. Documentation of Preservation Intervention at the Hill Wing, c. 1990/1991. This photo shows the new retaining wall adjacent to the existing limestone foundation retaining wall of the Hill Wing. This wall was installed to support the existing wall (after it was correctively jacked back into a vertical position.) Note how the new retaining wall was built away from the existing limestone wall, only making contact at select points. This area was eventually reburied, meaning the new concrete wall is now invisible, photo courtesy TPI.

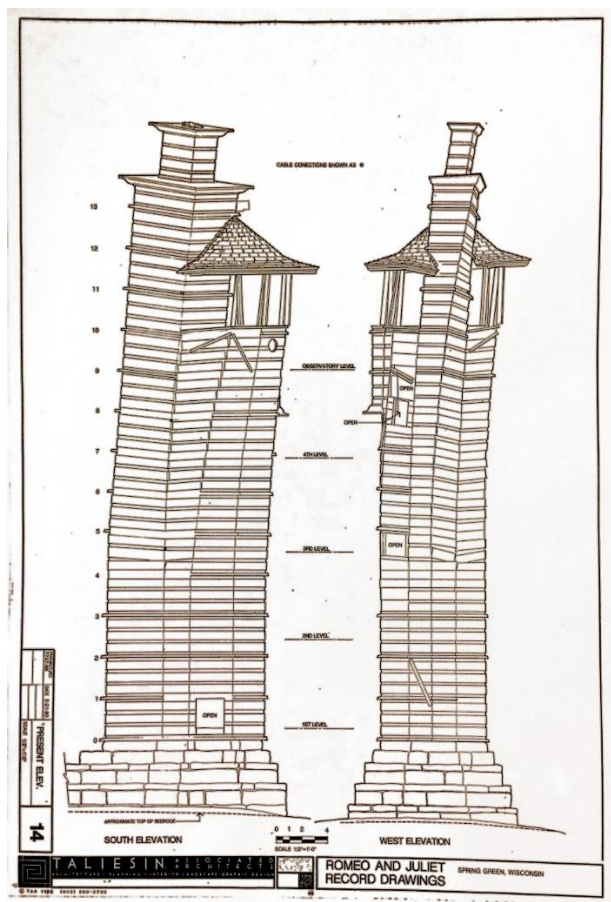
Figure 29. Measured drawing produced by TAA showing the measured twisting and racking of the R&J Windmill. This drawings was produced as part of an HSR/HABS package for preservation grant funding. Eventually, the windmill was deconstructed and reconstructed by TAA, drawing courtesy of the Frank Lloyd Wright Foundation Archive at Avery Library.

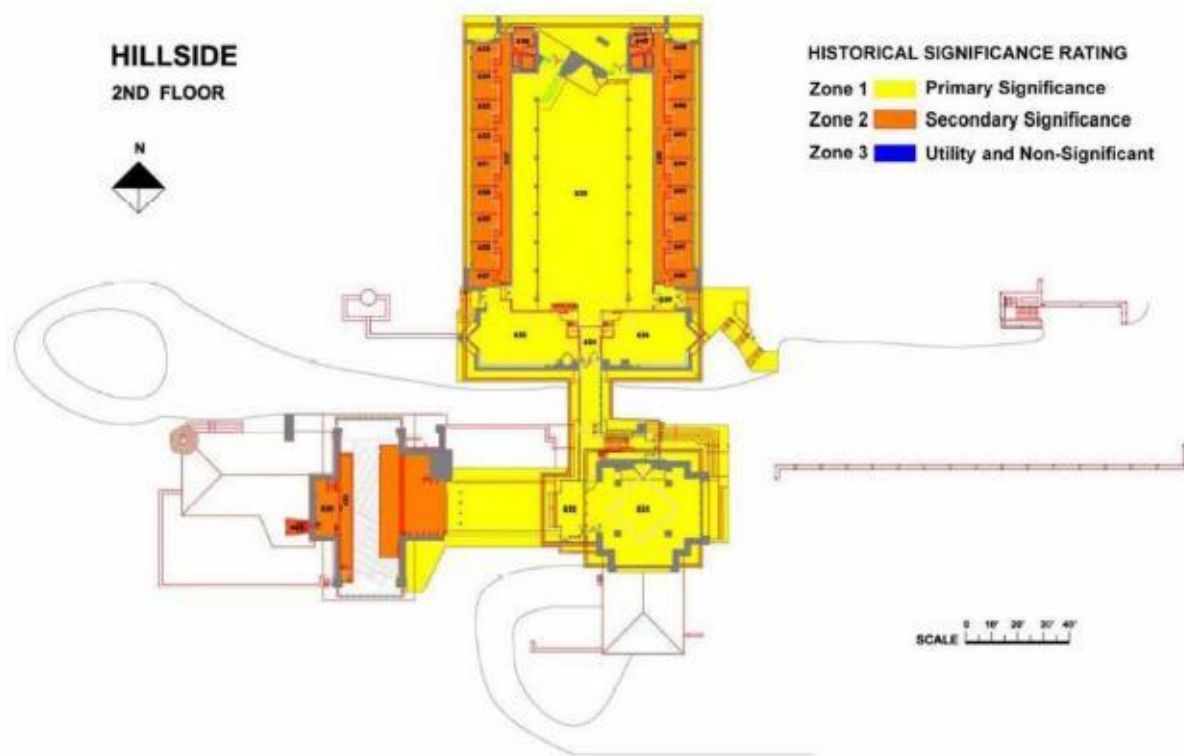
Figure 31. Capture from TPI's 2013 Preservation Policy denoting Zones of Significance within the Hillside School.. Note that the drafting studio (large central space) is designated with primary significance and surrounding student quarters have secondary significance. This diagram comes from the May 2013 version of TPI's Preservation Policy, courtesy of TPI.

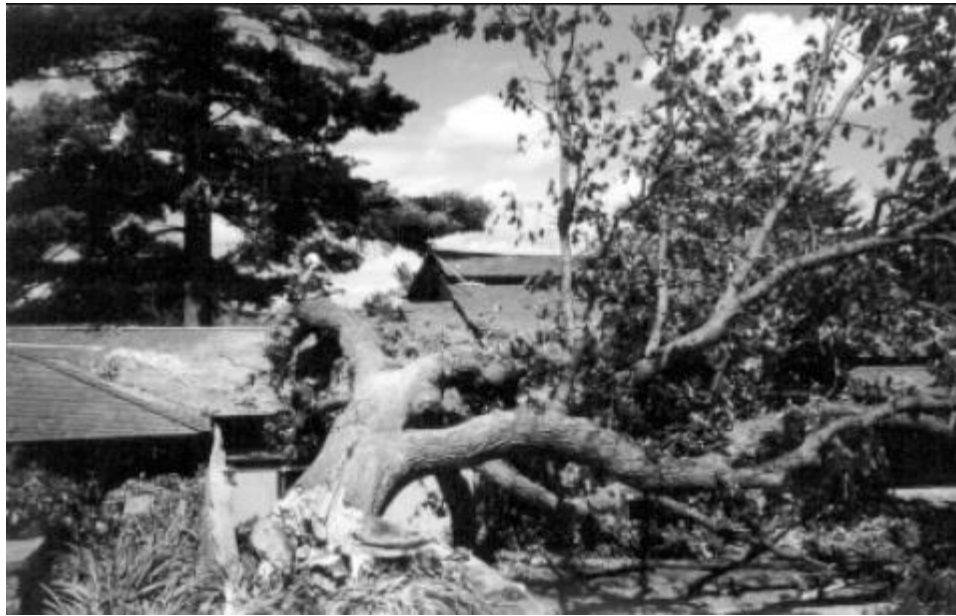
Figure 32. Image of the fallen Tea Circle Oak in 2008. During a storm, the tree fell onto the roof of Wright's studio, a space that had never been destroyed by fire. The comprehensive restoration of this area was funded by an insurance claim, and is one of the few instances in which the preservation team used a consulting firm to design the majority of the intervention. Silman, an east-coast preservation firm designed the intervention, but eventually left the project, which was largely implemented by TPI's construction crew, photo courtesy TPI.

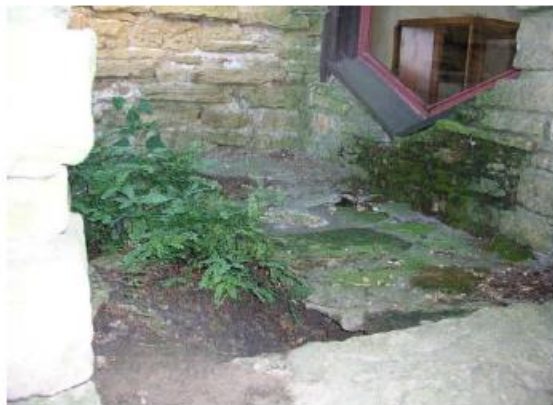
5.04 Little Kitchen (Room 24) window, 2005.
Roof runoff has created problems in the area outside the hexagonal kitchen window; there is a significant washout hole in the flagstone.

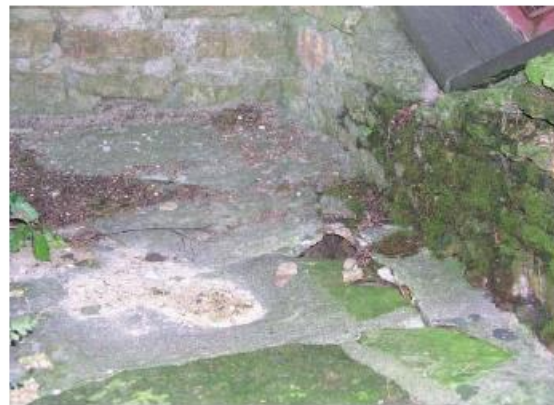
5.05 Washout hole outside Little Kitchen (Room 24) window, 2005.
Close examination reveals a second washout hole. Both of these washout holes convey runoff water under the building.

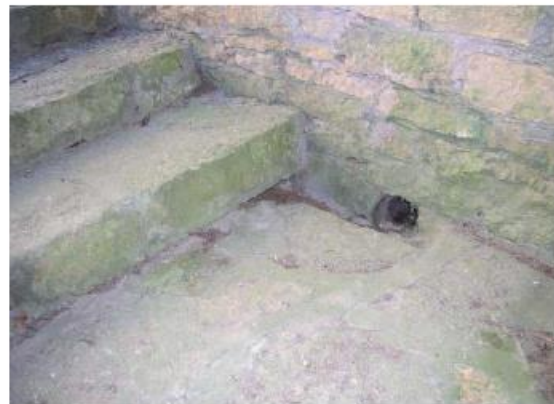
5.07 Guest Wing (Room 1) step washout, 2005.
A washout hole has developed at the base of the bottom step to the Guest Wing, adjacent to an apparently functional drain. This washout may be caused by water at the top of the steps moving through the flagstone.

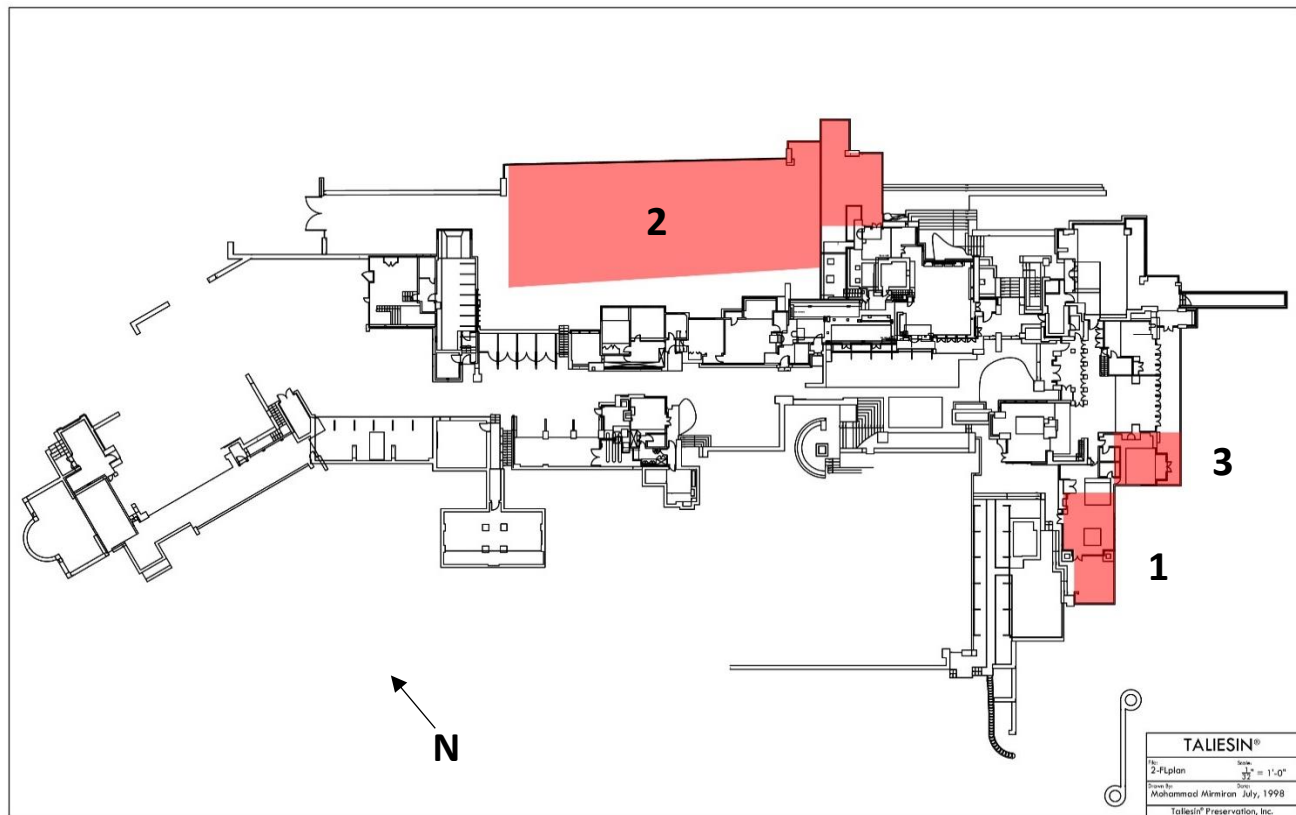
Figure 35. Plan of Taliesin showing three case study areas. Plan from TPI, edited by author.

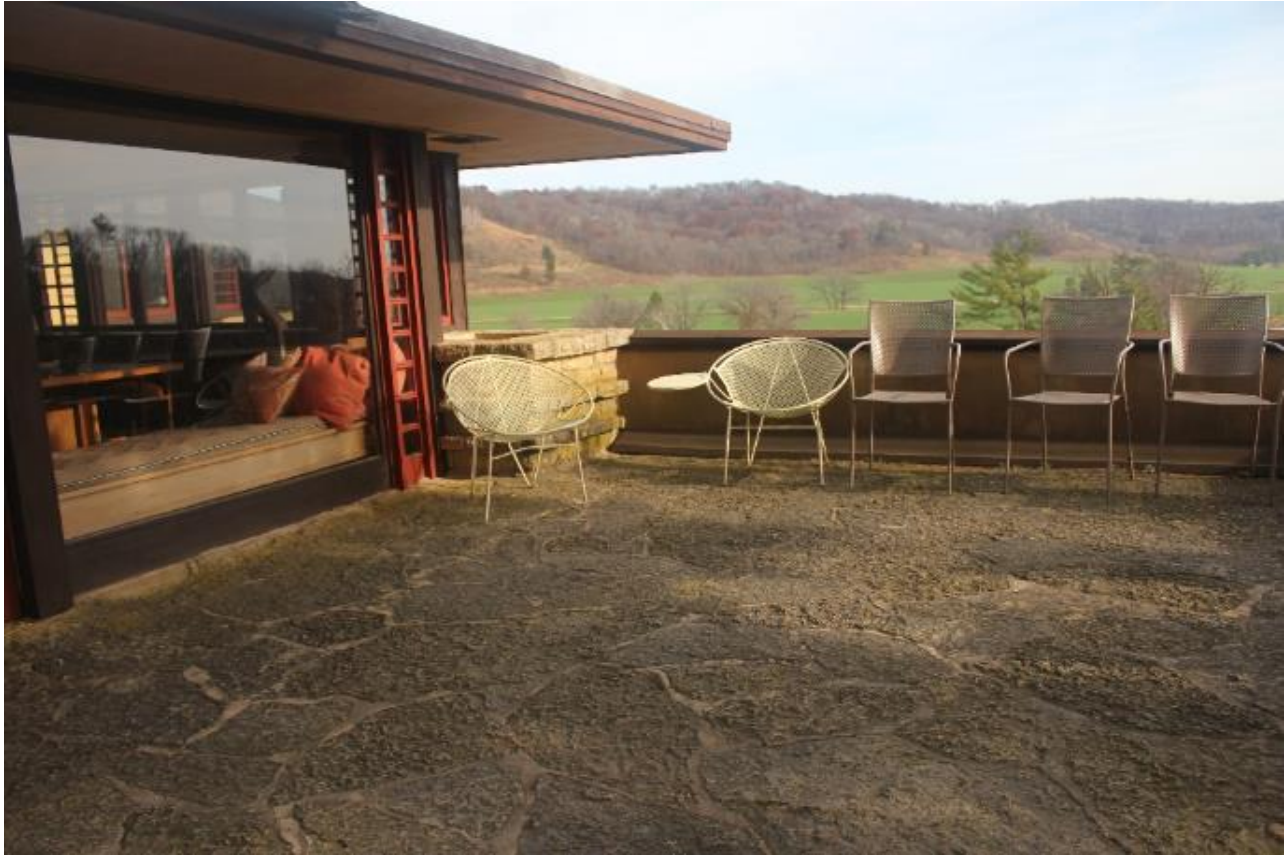
Figure 36. Mr. Wright's Bedroom Terrace, looking east over cantilevered edge, Mr. Wright's bedroom visible at the left, photo taken twenty-seven years after structural stabilization project, photo by author, 2016.

Mr. Wright’s Bedroom Terrace is located in the southernmost corner of Taliesin, at the west side of Mr. and Mrs. Wright’s personal residence (Figure 36). The area as it exists today was constructed by apprentices in 1936 within the Taliesin III era. However, each subsequent modification was an extension or reconstruction of the earlier versions of the building, so it is possible that some of this area’s material, such as the stone piers date back to the first iteration of the building from 1911¹²¹. Like the rest of the main residence, the terrace area went through a number of iterations from during Wright’s lifetime, as well as after his death in 1959. As a first piece of this preservation project, TPC compiled a construction chronology of the room from oral histories, historic photographs, historic working drawings, and observed conditions. To give context, a summarized version of that history is included here.

The terrace was constructed by Wright and apprentices in the summer of 1936 as a modification of the entry drive (no longer extant) and the reconfiguration and extension of Wright's bedroom. As reported by an apprentice in a 1937 newspaper column, the terrace was meant for private use by Mr. Wright, but also as a wing to intercept the entry drive, a cantilever terrace high in the air and a section of the house that "sprouted a new branch to meet all arrivals."¹²² The area comprised a small enclosed bedroom for Mr. Wright and a large, partially-covered, outdoor terrace, measuring 28' long by 18' wide. The roof above was supported on wood posts at the perimeter of the terrace. The roof also featured a skylight above outdoor section. This outdoor section was edged in low stone walls or stucco half-walls. Rough paving stones covered the floor surface of the bedroom and terrace space, and similar to other sections of the house, these paving stones were set into sand bedding on top of wood decking. The terrace met the grade of the hill at the west, but cantilevered out over the slope along its east side where the hill descended sharply down to the entry drive. The entire structure was supported on wood joists and wood beams that cantilevered out from stone piers¹²³ (Figure 36).

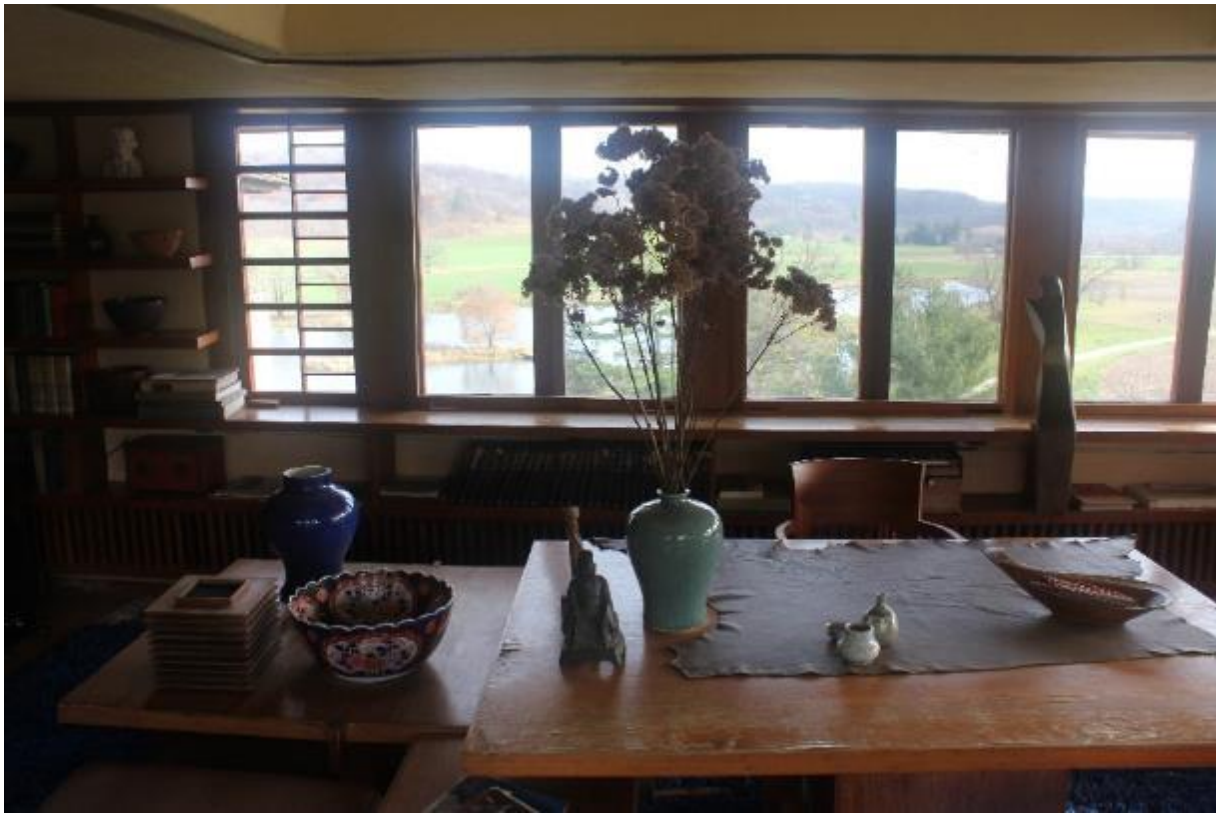
Figure 38. Mr. Wright's Bedroom Interior, as restored in 2010. This image taken from Bedroom Interior, looking southeast out of windows that are visible in Figure 37. Photo by author, 2016.

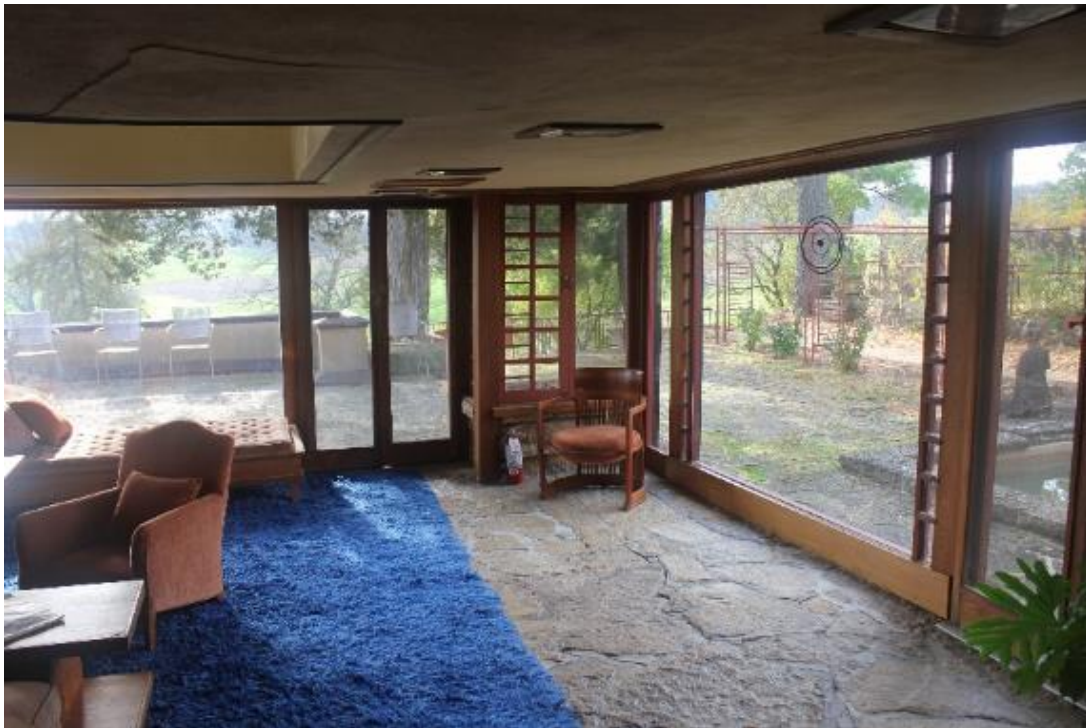
Figure 39. Mr. Wright's Bedroom Interior, looking south, cantilever terrace is visible outside at left. Photo by author, 2016.

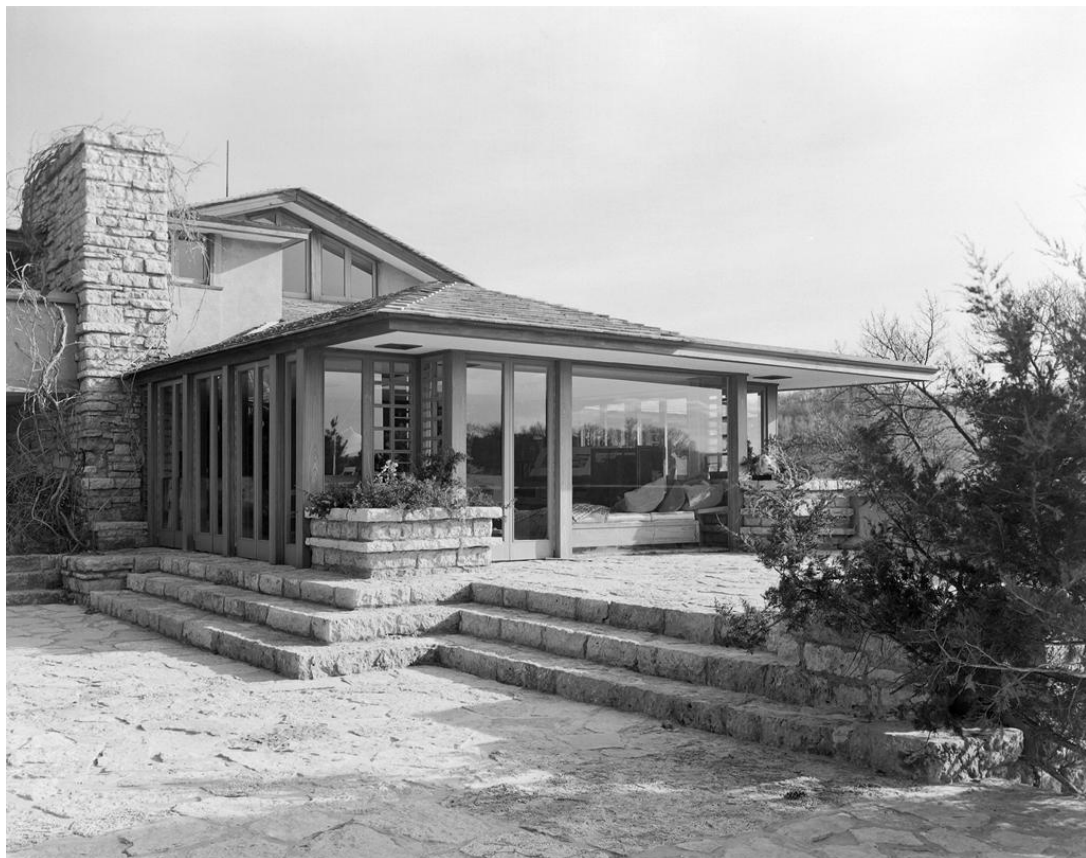
Figure 40. Mr. Wright's Bedroom, looking north. Historic Photograph circa 1940s, Mr. Wright's Bedroom Terrace visible along the right side. Photo looks back at the area seen in Figure 39. Photograph by Ezra Stoller, photo courtesy of Esto Images and Frank Lloyd Wright Foundation Archive.

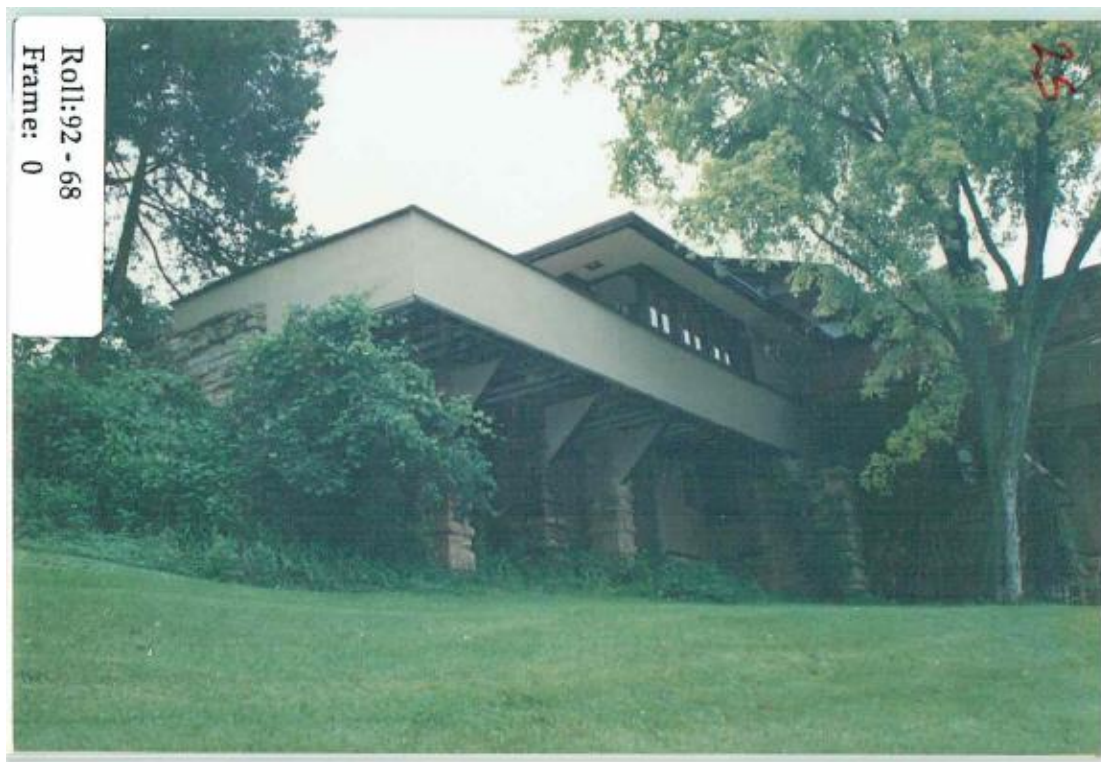
Figure 41. Mr. Wright's Bedroom Terrace from below, looking north. Photo from 1992 before stabilization project. Note the 45 degree triangular braces that were added between 1959 and 1992 visible at each limestone pier, photo courtesy of TPI.

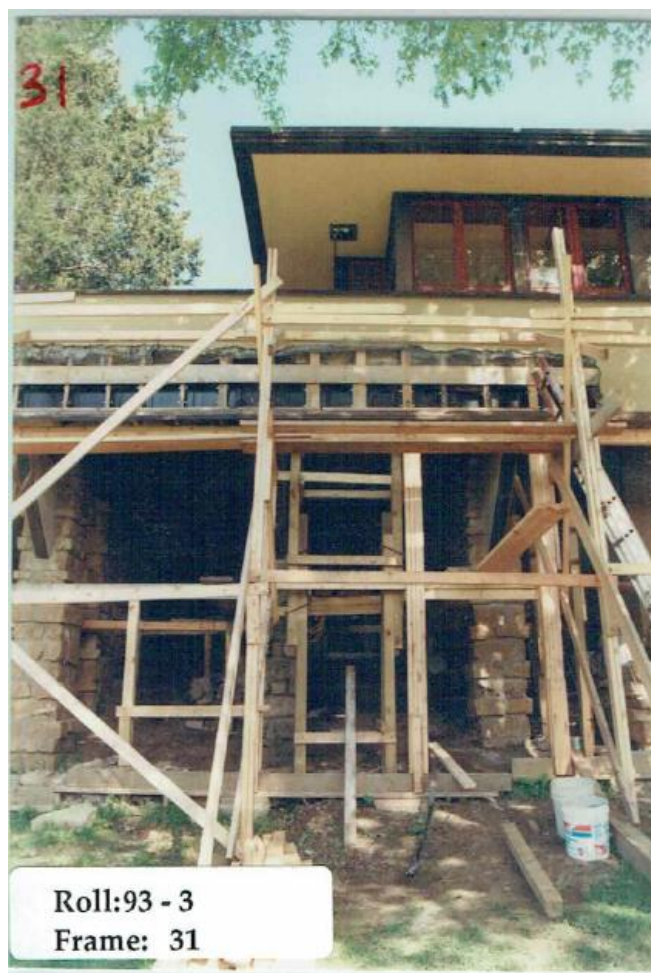
Figure 43. Mr. Wright's Bedroom Terrace from below showing shoring and deconstruction of the parapet wall, c. 1992 and 1993, looking northwest. (studs and black membrane are visible at the top of the shoring), photo courtesy of TPI

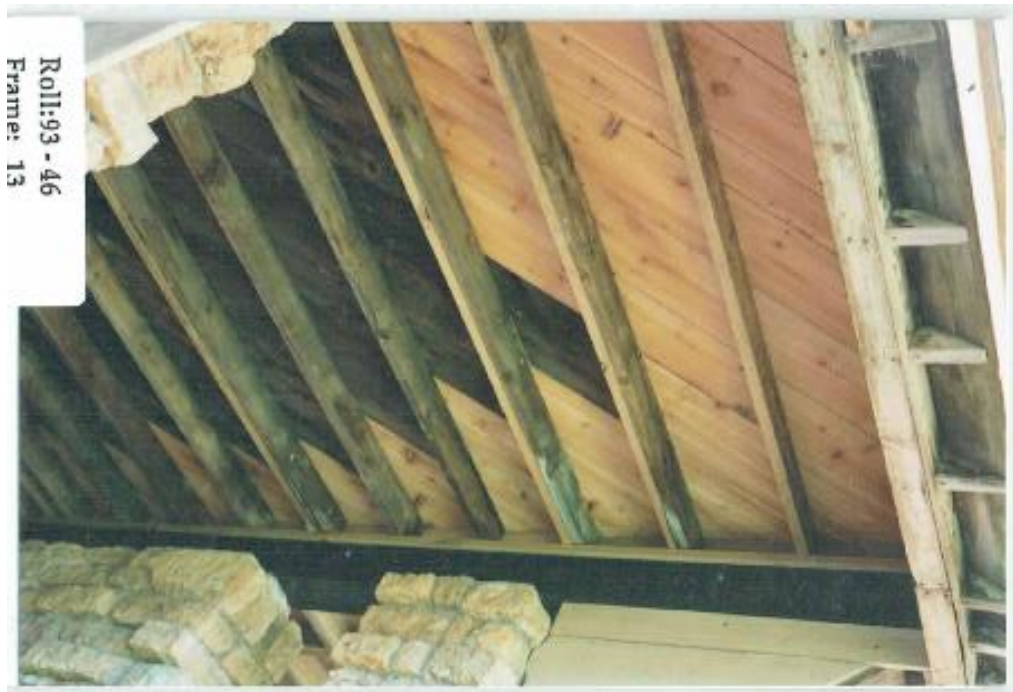
Figure 44. Mr. Wright's Bedroom Terrace from underneath/below, shoring new decking, salvaged material, and new steel, c. 1992/1993. New steel beam can be seen along the top of the limestone wall. Where water damage was the worst, around exterior portions, decking was replaced in-kind. A new waterproof membrane was also added above. Photo courtesy of TPI.

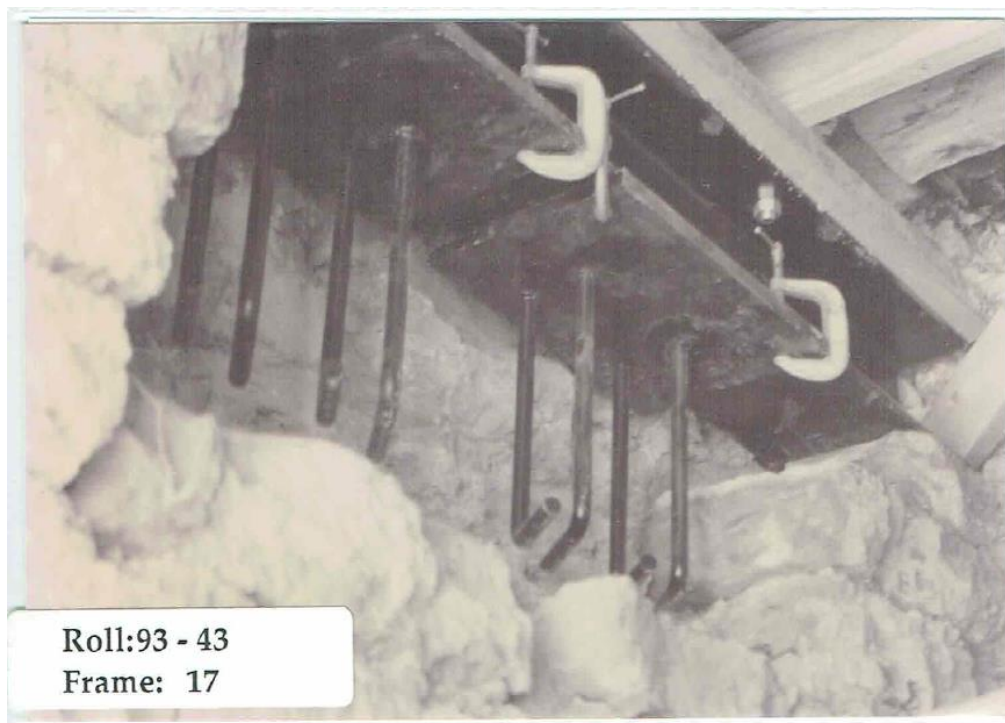
Figure 45. New anchors at the meeting of existing limestone piers and the new steel. Existing limestone was chased out to provide space for steel anchors. Gaps were then filled with concrete to provide "backspan" support for the cantilevered terrace, Photo courtesy of TPI.

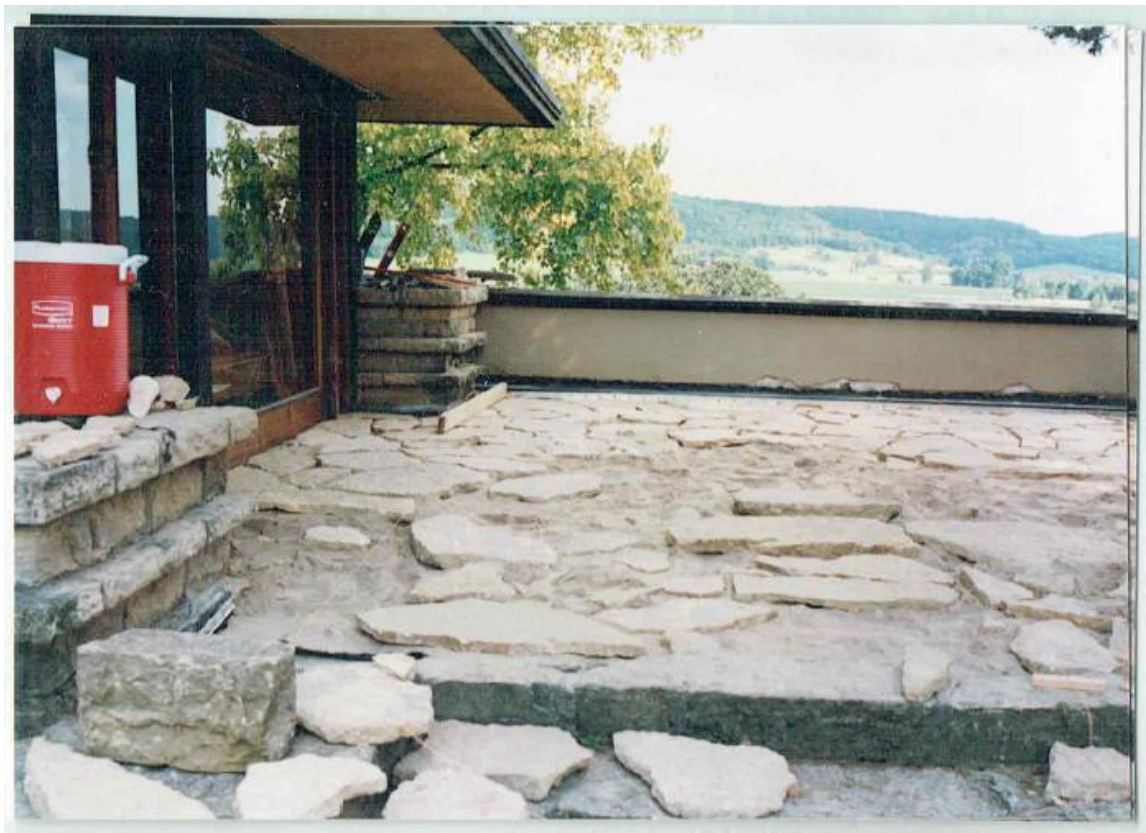
Figure 46. Resetting stone paving after decking repairs, 1993, photo looking southeast over the parapet edge, courtesy of TPI.

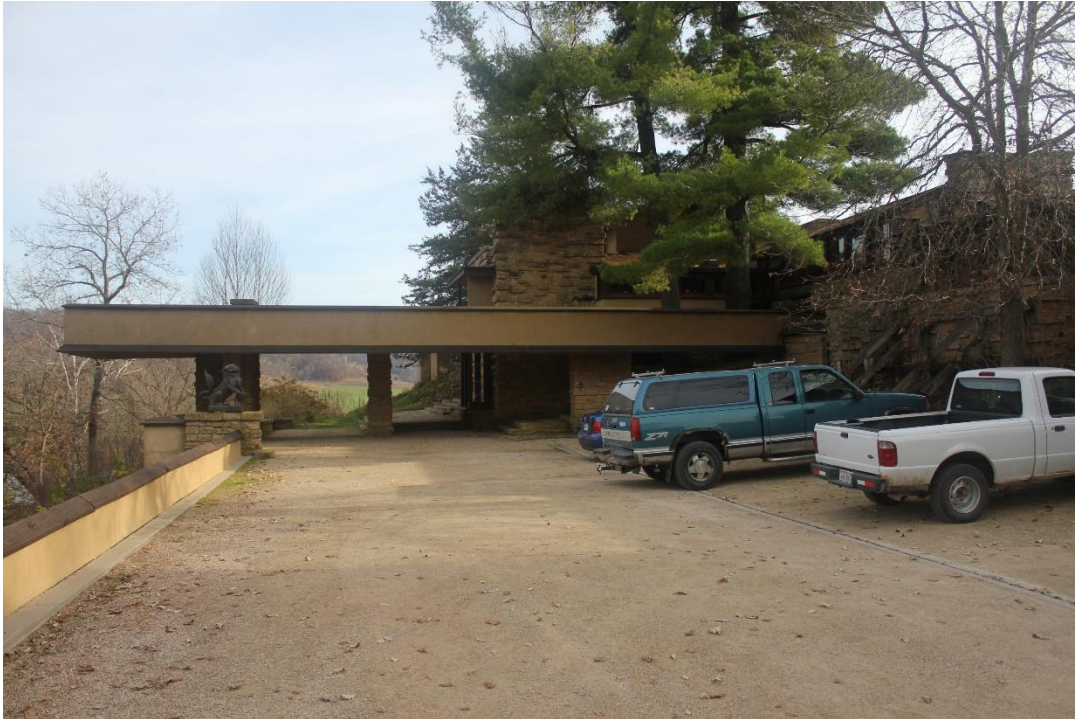
Figure 47. Lower Court, looking southeast from entrance gate. Cantilever edge along the left side, Parking and private apartments along the right side. Wright's Studio Terrace balcony is visible in the distance, supported by various limestone piers. Photo by author, 2016.

The lower court at Taliesin is located at the northeast side of the property. The gravel court is used for parking and is accessible from Taliesin's current main drive, which winds up from County Road C at the north (Figure 47). This area of Taliesin was chosen as a case study because of its structural nature, and because the treatment of this area showcases represents a variety of technical approaches and preservation philosophies all within a small area designated a space of primary significance.¹³³
