PRESERVATION, MANAGEMENT, AND STABILIZATION
APPROACHES AT FRANK LLOYD WRIGHT'S TALIESIN
AN ANALYSIS OF THE EVOLUTION OF INTERVENTION STRATEGIES

Allison Semrad

Submitted in partial fulfillment of the requirements for the degree
Master of Science in Historic Preservation

Columbia University
(May 2017)

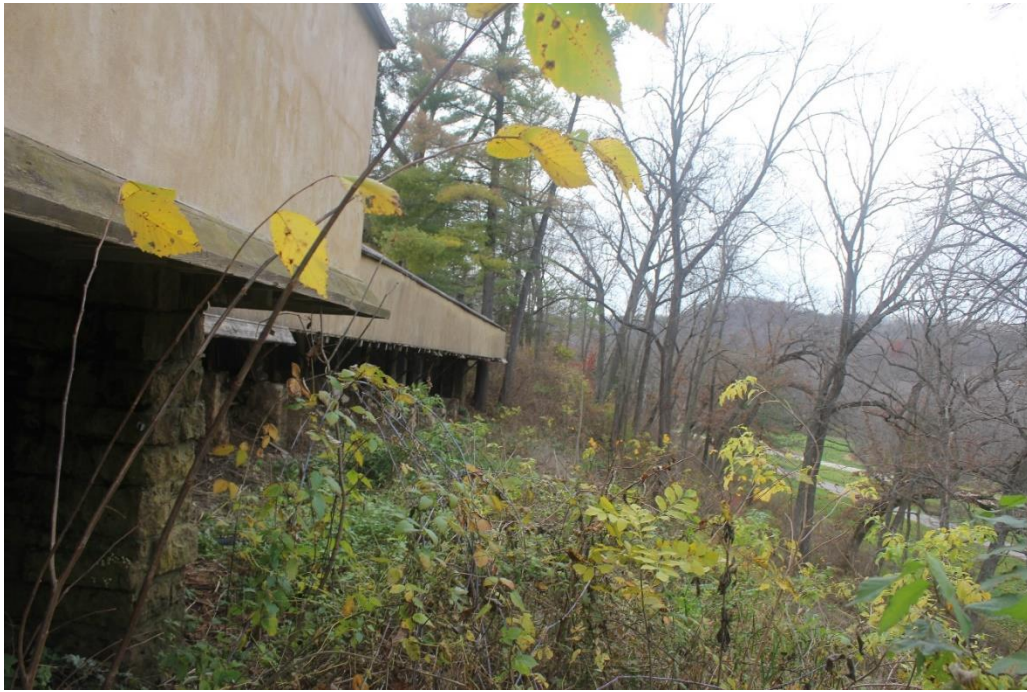
Figure 48. Lower Court from below, looking northwest. Not the deteriorated condition along the lower parapet edge, and the dense vegetation surrounding this area. Also note the length of this area and how the structure is relatively invisible, even from this lower perspective. Photo by author, 2016.

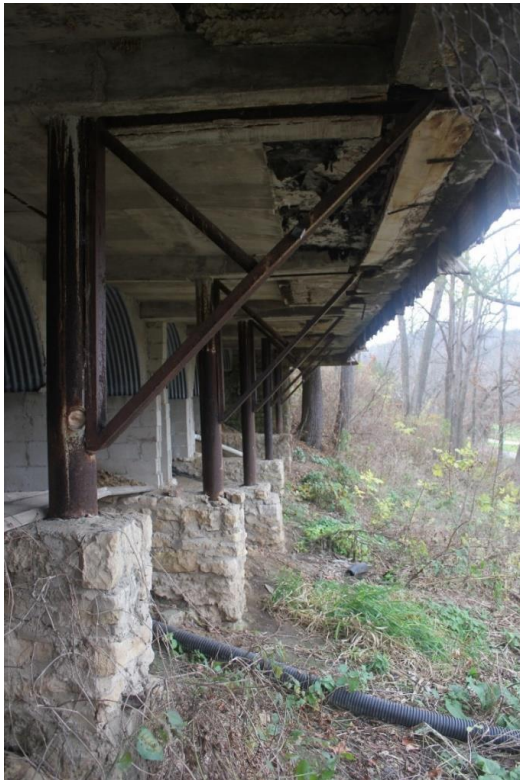
Figure 49. Northern section of the Lower Court structural system, suspected 1980s intervention in poor condition, photo by author circa 2016.

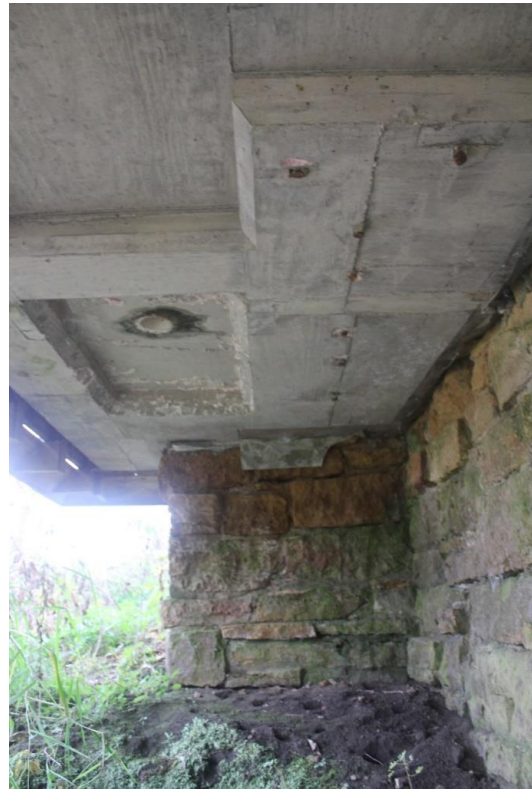
Figure 50. Southern section of the Lower Court structural system showing new RC slab, circa 1994.

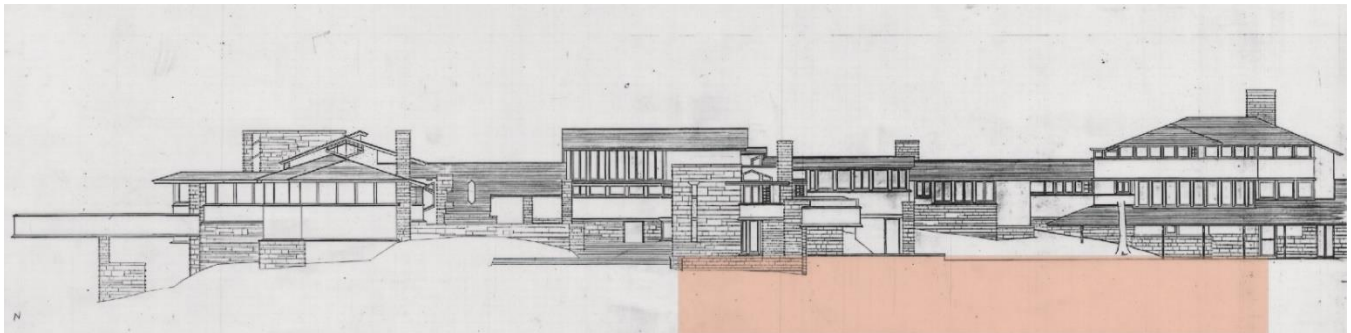
Figure 51. *Getty Survey Drawings, c. late 1980s, Area of the Lower Court Support System marked in Red. Drawing courtesy of Frank Lloyd Wright Foundation Archives at Avery, edited by author.*

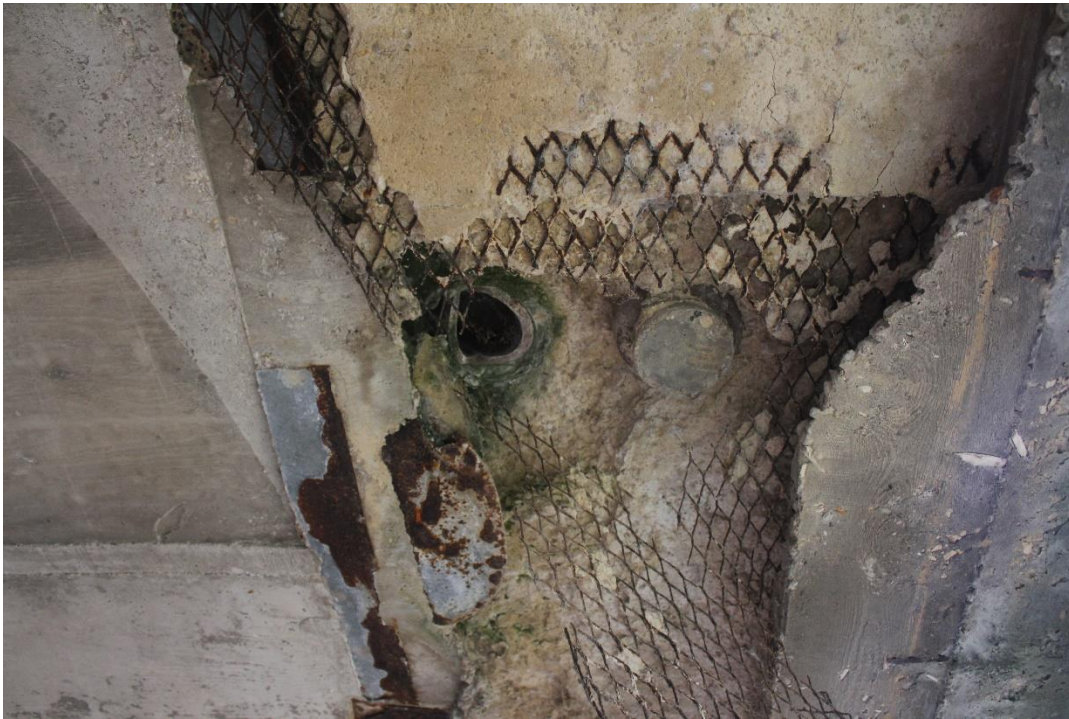
Figure 53. Underside of northern section of Lower Court, note the multiple layers of plaster, concrete, exposed lath, and the visible terra cotta drains, photo by author, November 2016.

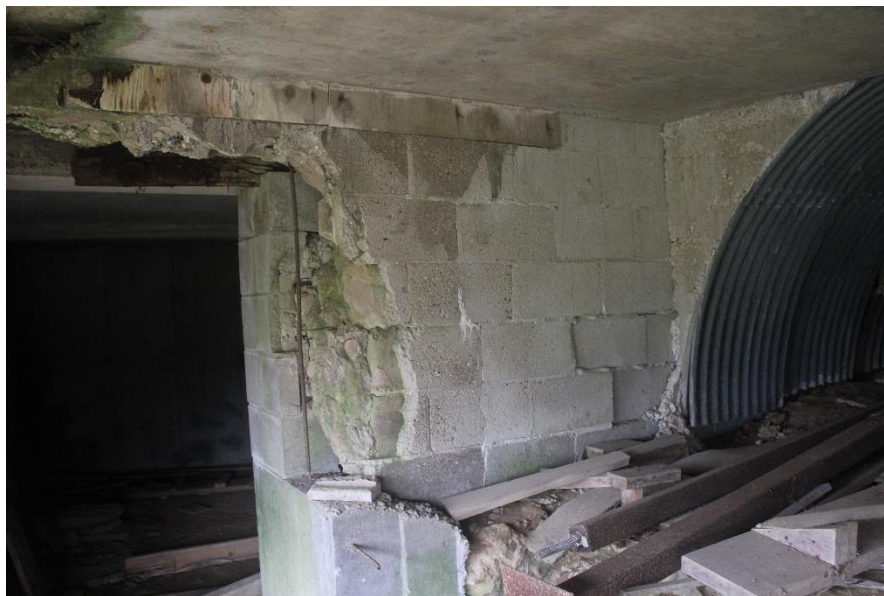
Figure 55. New utility vault entrance showing meeting of new concrete vault (left) and the existing 1980s concrete intervention (right), November 2016, photo by author.

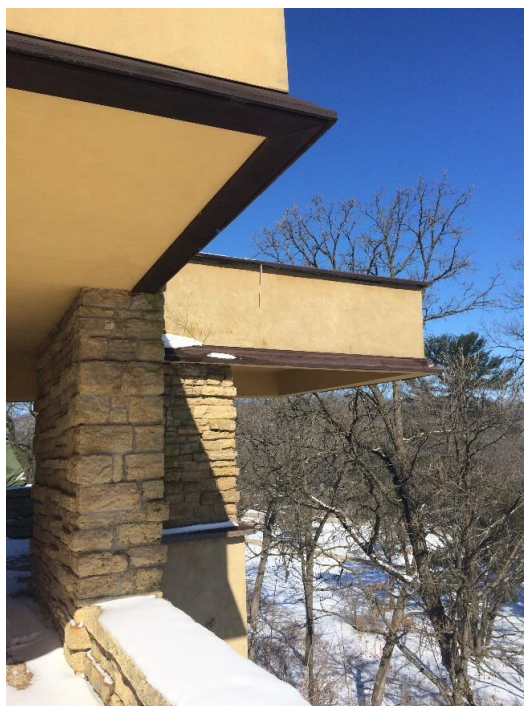
Figure 56. Lower court and Studio Balcony Terrace, 2017, note the limestone piers, now supported by the RC slab installed in 1994, photo by author.

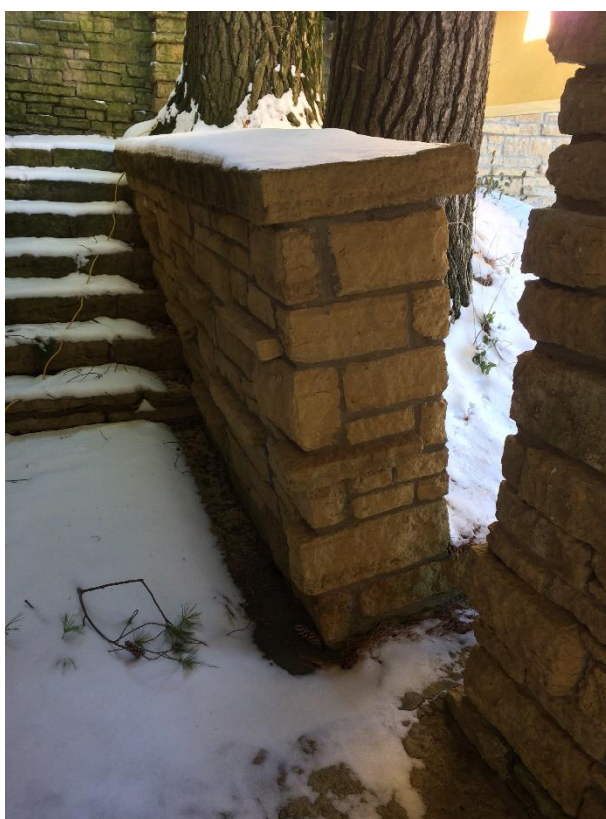
Figure 57. Stone wall at the western edge of the lower court. note the deformation of the wall because of the mature tree behind it. This is an example of the problems that will be tackled by UW-Madison Engineering Capstone proposals.

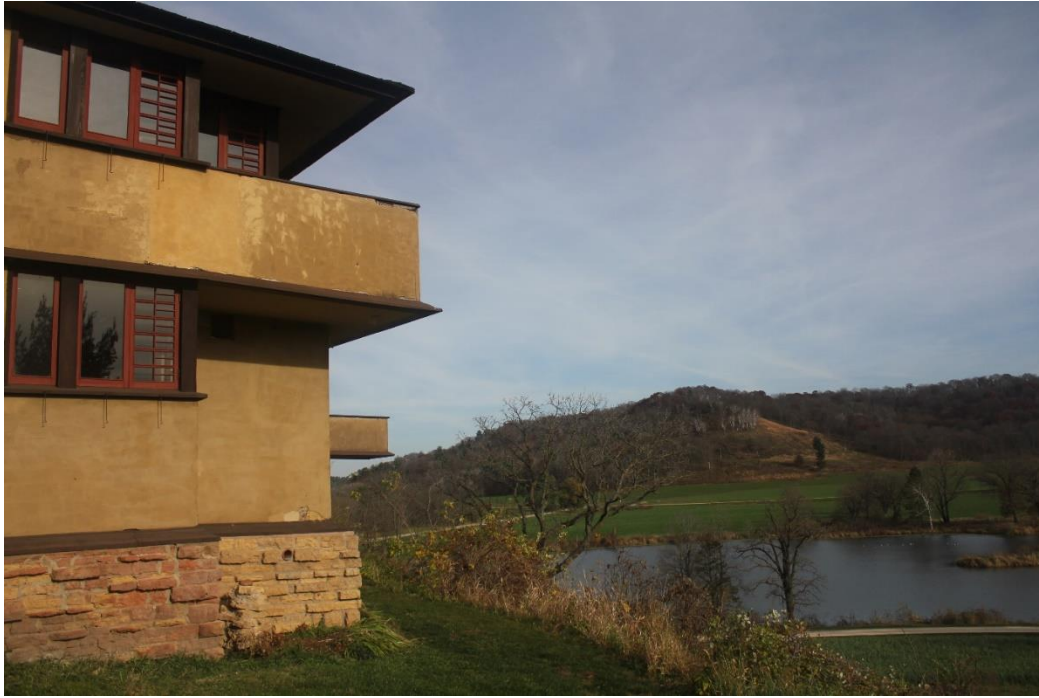
Figure 58. Exterior, showing Gold Room (lower level) and Mrs. Wright's room above, including exposed terrace. Photo taken from south side of building, looking east out to ponds and hills beyond. Photo by author, 2016.

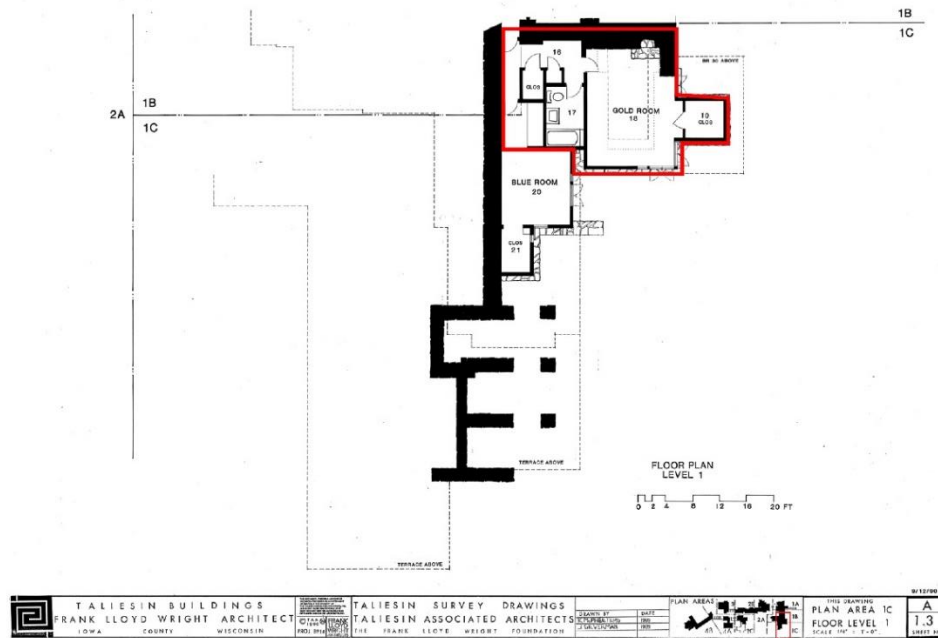
Figure 60. Partial Getty drawing showing Gold Room outlined in red. Note that Mr. Wright's terrace area is also showing in this plan, as the three stone piers near the bottom of the plan. Plan courtesy of Frank Lloyd Wright Foundation Archive at Avery Library.

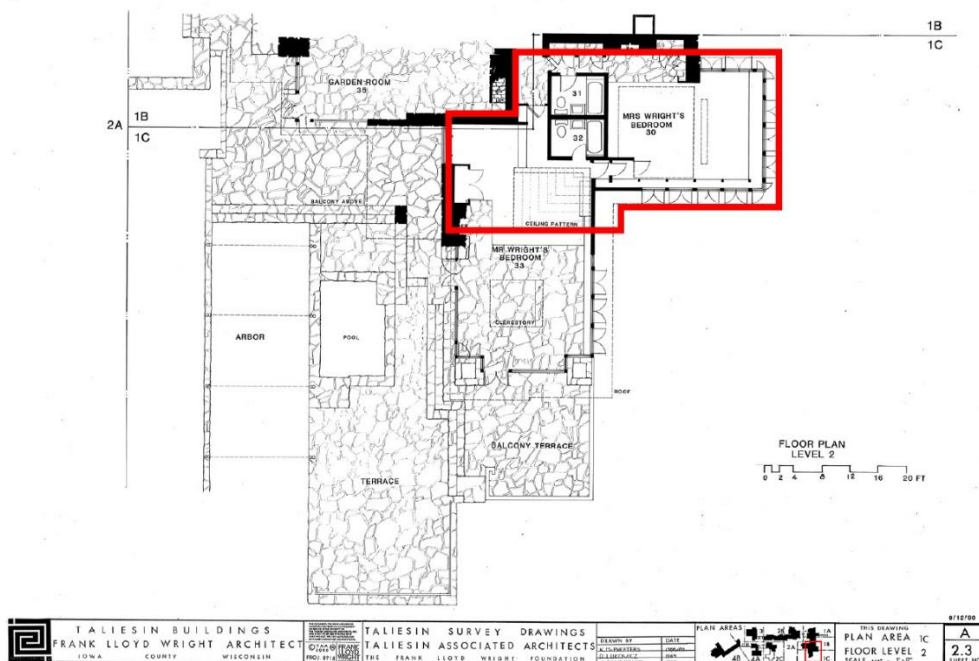
Figure 61. Partial Getty plan showing Mrs. Wright's Room outlined in red. Note that this level of the house (comprising the "period rooms" features a floor of stone paving. Mr. Wright's Bedroom and Terrace also visible near the bottom of this plan, Plan courtesy of Frank Lloyd Wright Foundation Archive at Avery Library.

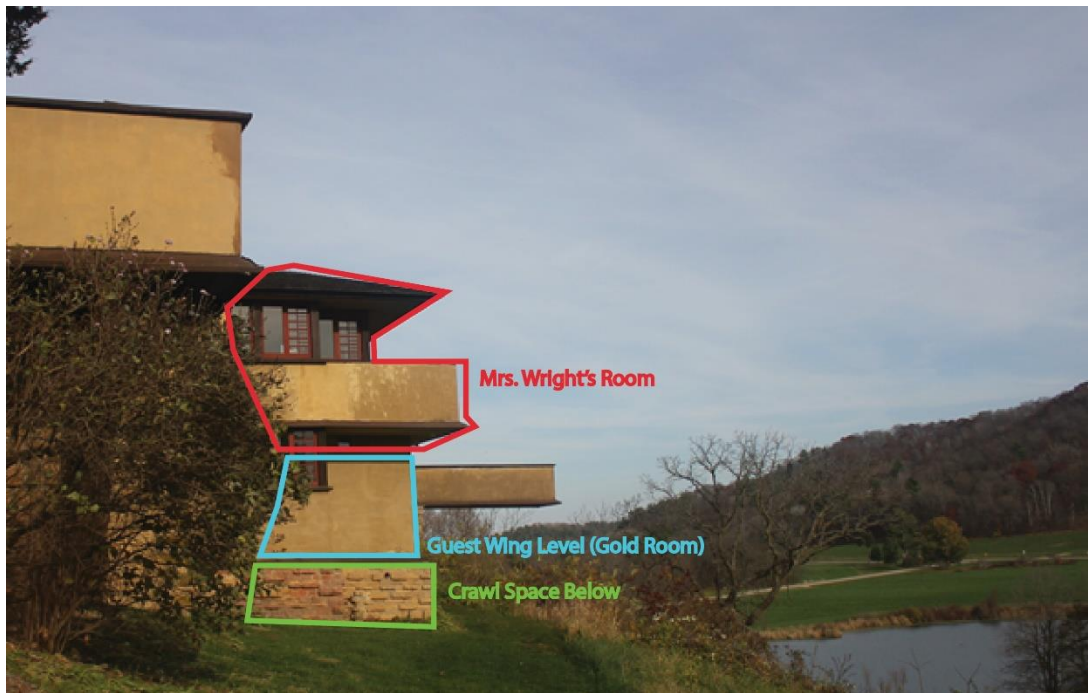
Figure 62. Photo of exterior of main residence, looking northeast. Each level of the residence is outlined, showing the crawlspace below, Gold Room within the Guest Wing, and Mrs. Wright's Room above. Photo by author 2016, edited.

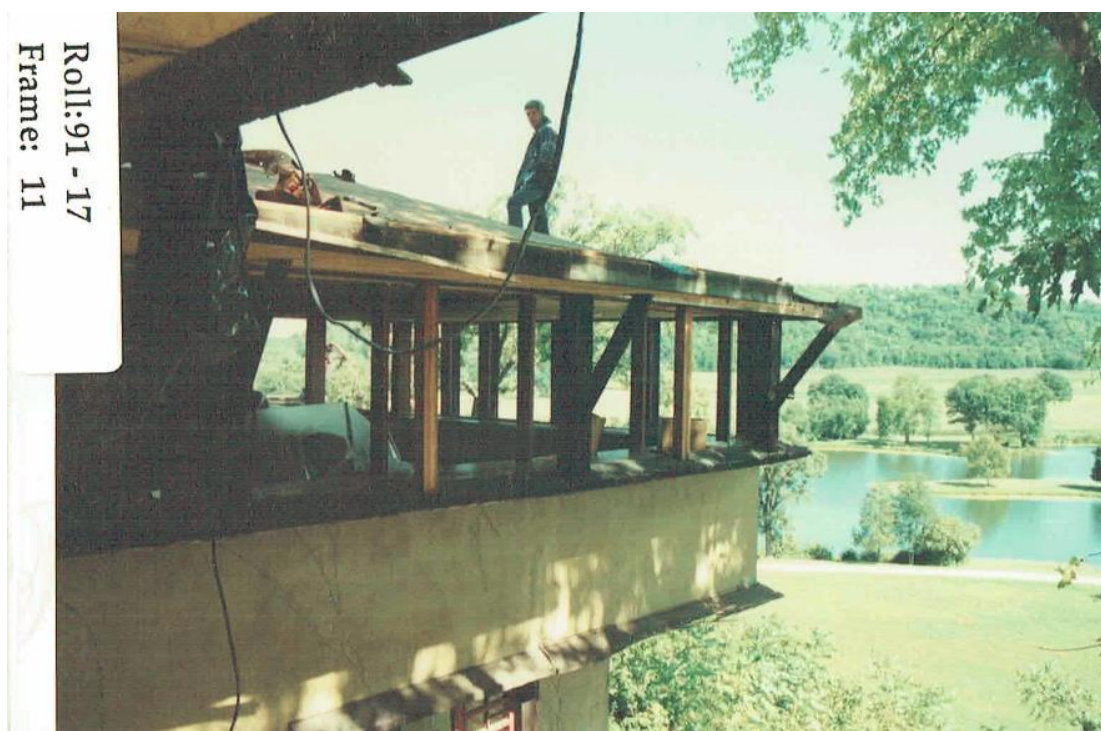
Figure 63. 1991 photo showing the deconstruction of the exterior of Mrs. Wright's room (by the Fellowship), photo taken from Mr. Wright's Room, looking east, Note the multiple layers of exterior wall, where the perimeter of Mrs. Wright's room was suspected to have been extended. Also note the absence of any exterior terrace in 1991 (which was eventually restored by the Fellowship work crew and TPI.) Photo courtesy of TPI.

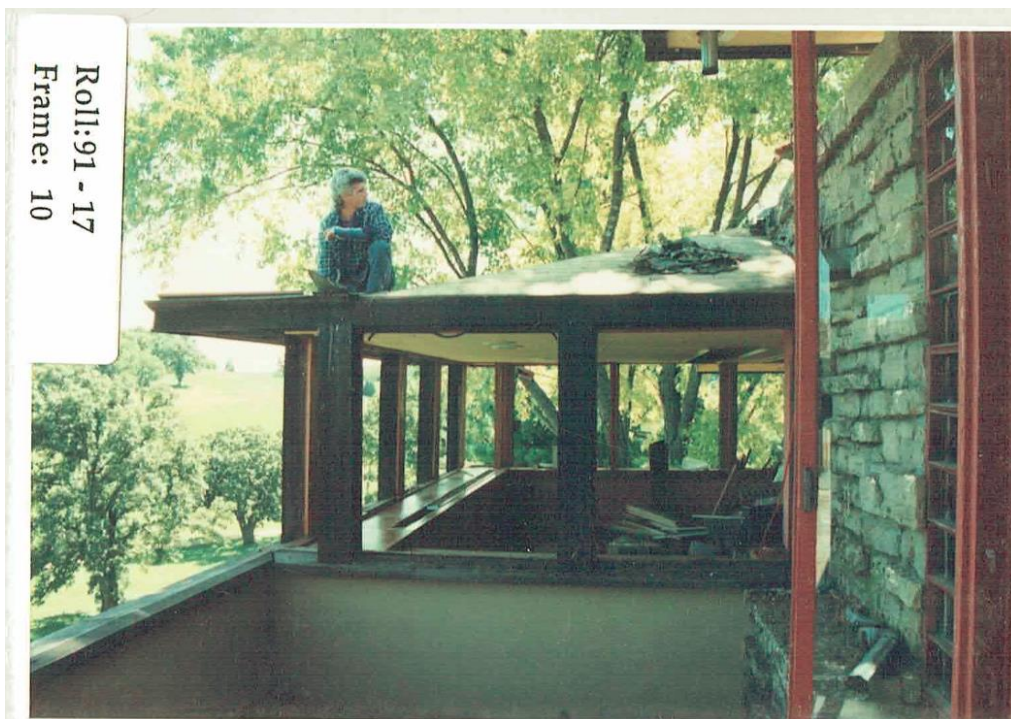
Figure 64. 1991 photo of the deconstruction of Mrs. Wright's Room, looking southwest from the loggia terrace. Note the absence of exterior terrace within the boundaries of Mrs. Wright's room. The stone at the left side forms the fireplace and supporting wall, continuous down through the Gold Room. Photo courtesy of TPI.

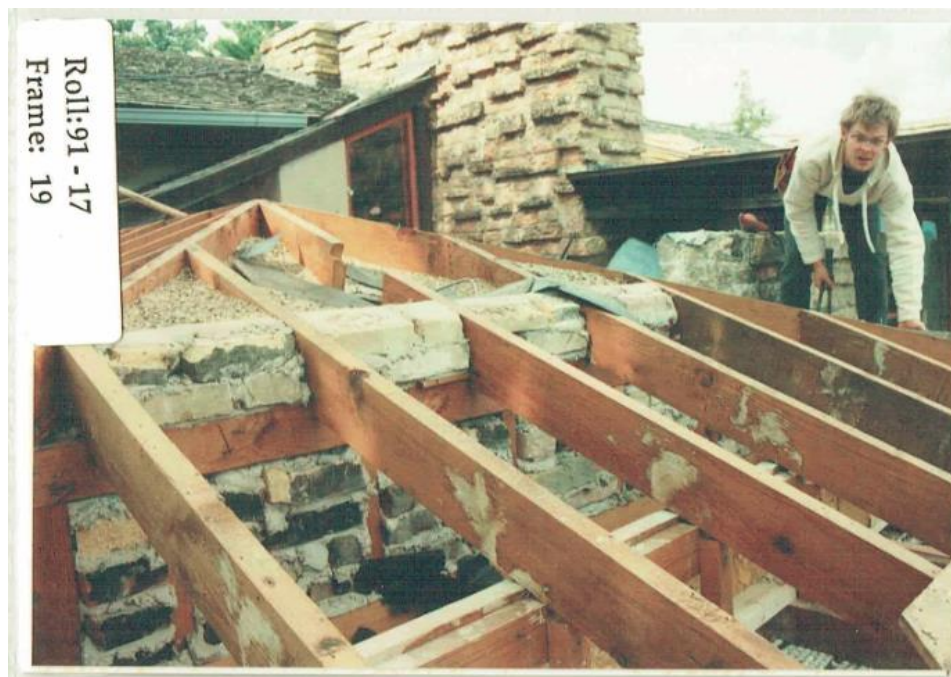
Figure 65. 1991 photo showing the Fellowship work crew removing an existing (and suspected later addition) roof over Mrs. Wright's Bedroom, Photo looking west.. Note the brick backing visible in the photo between the two roof layers, highlighting the many layers and complexity of this structure. Photo courtesy of TPI.

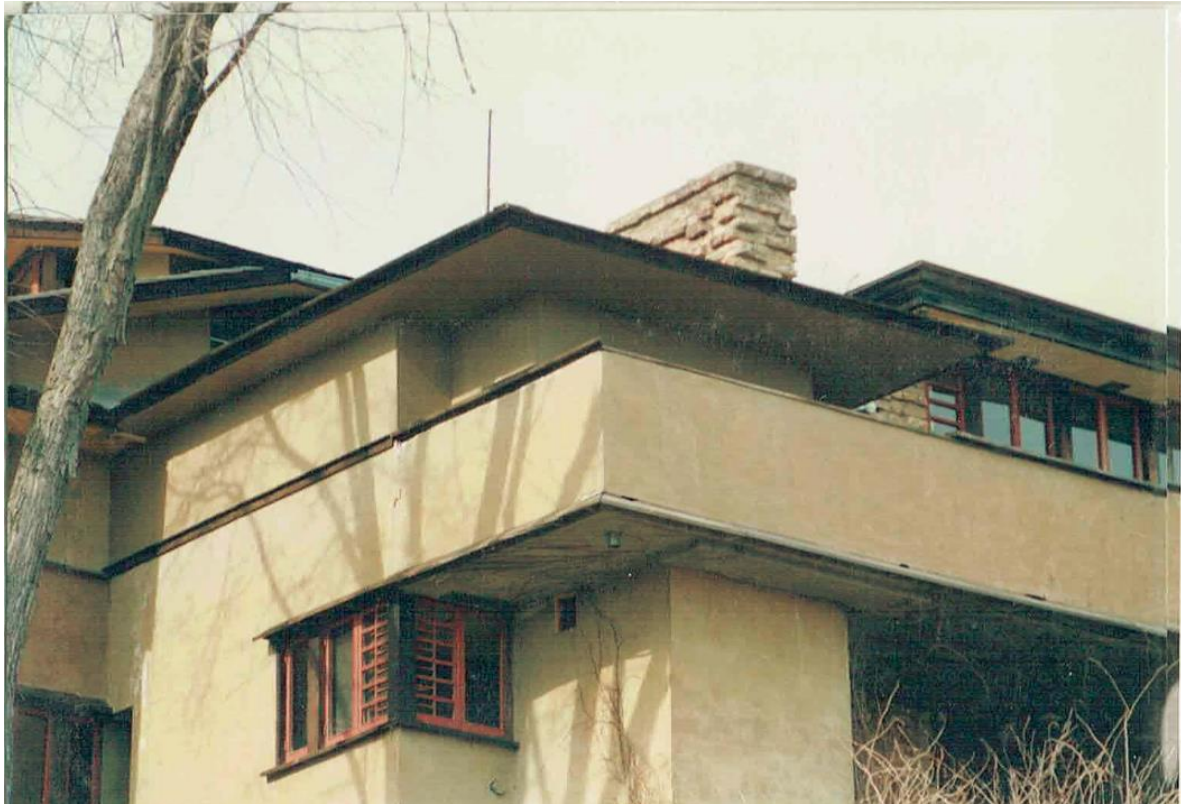
Figure 66. Exterior of Mrs. Wright's room, looking west, showing "mothballed" condition in place 1991 through 1996 whereby the walls were covered in temporary sheathing. Photo courtesy TPI.

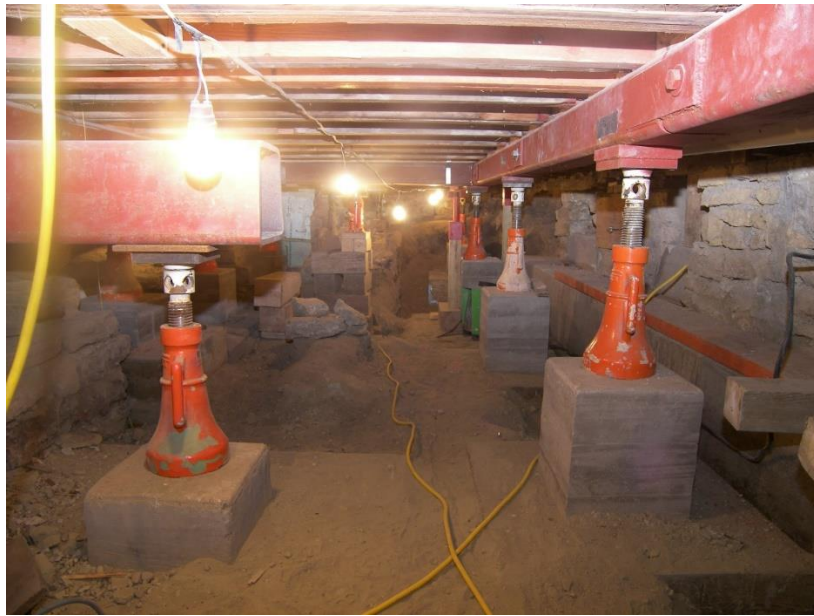
Figure 68. Photo of in-progress jacking, whereby jacks were place on top of new concrete footings, to support new steel underneath the existing floor. The jacking slowly lifted the steel and floor joists above to correct the structure to be plane above, Photo from 2008 taken in crawl-space below Gold Room, courtesy of TPI.

Another final piece foundation stabilization project consisted of corrective jacking procedure (Figure 68). This consisted of installing hand jacks on top of the new concrete footings, which would provide temporary shoring for the structure above, and also create a level, stable floor level for the new steel beams and sistered floor joists (Figure 69). Jacking was carefully monitored and very slowly, the structure was lifted from its deflected positions. Some monitored locations moved up to 1 7/8 inches from their original positions.¹⁵³ Interestingly, there were already jacks present in the crawl space, indicating that the area had been correctively stabilized before, perhaps in the 1970s when other repairs were made to Mrs. Wright's room (Figure 70).

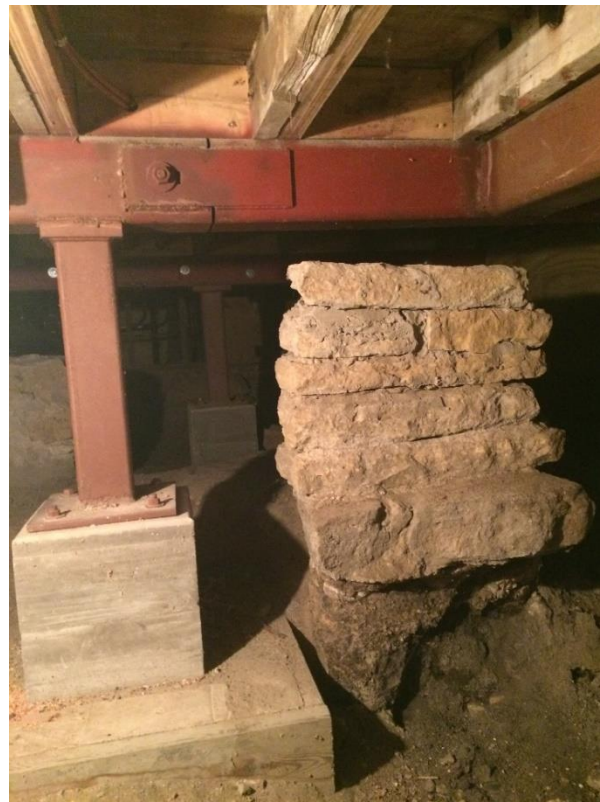
Figure 69. After jacks were removed, steel posts were installed to support the existing structure on the new concrete footings. Existing limestone footings (shown at right) are no longer load-bearing, but still extant beneath the existing Gold Room, Photo by author, taken in crawl space below the Gold Room, 2017.

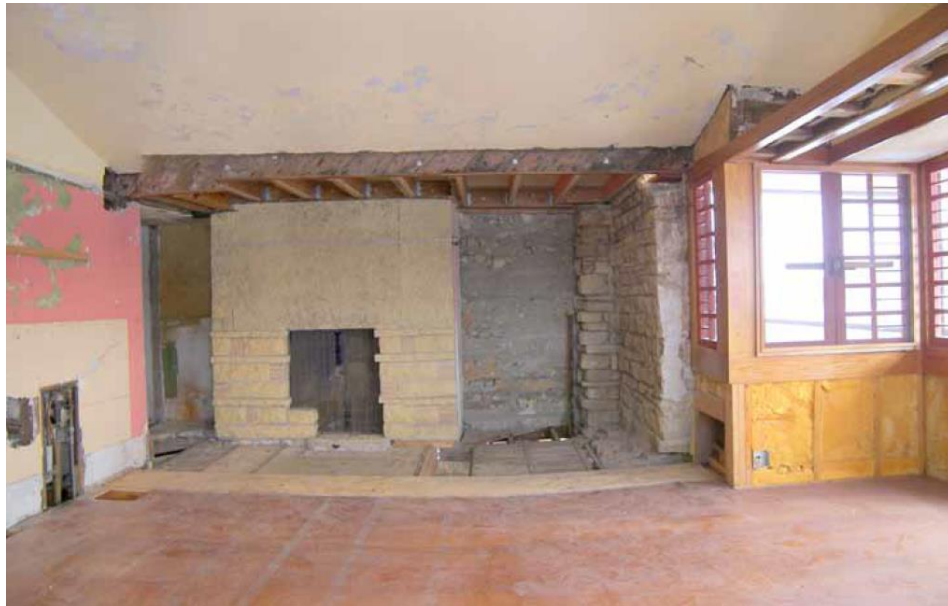
Figure 71. In-process documentation photograph taken by TPI, c. 2005 - 2010, showing unrestored condition of Mrs. Wright's room (condition dating to 1991 intervention). This wall is the northeast wall, along a stone wall (also visible from the outside in Figure 63. Photo from 2010 TPI Preservation Update, June 2010, photo courtesy of TPI.

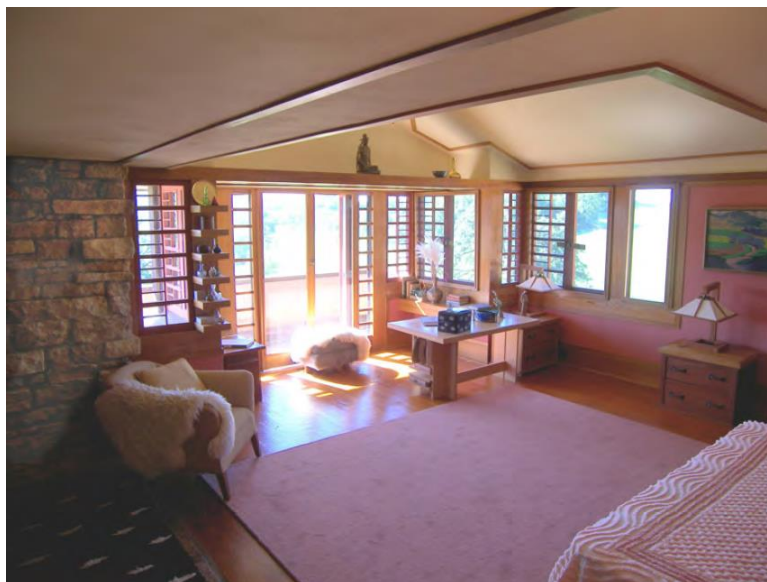
Figure 72. 2010 Photo of Mrs. Wright's Room restored, with interior furnishings and researched finishes, photo looking south out to exposed terrace, Photo from 2010 Preservation Update, Courtesy of TPI.

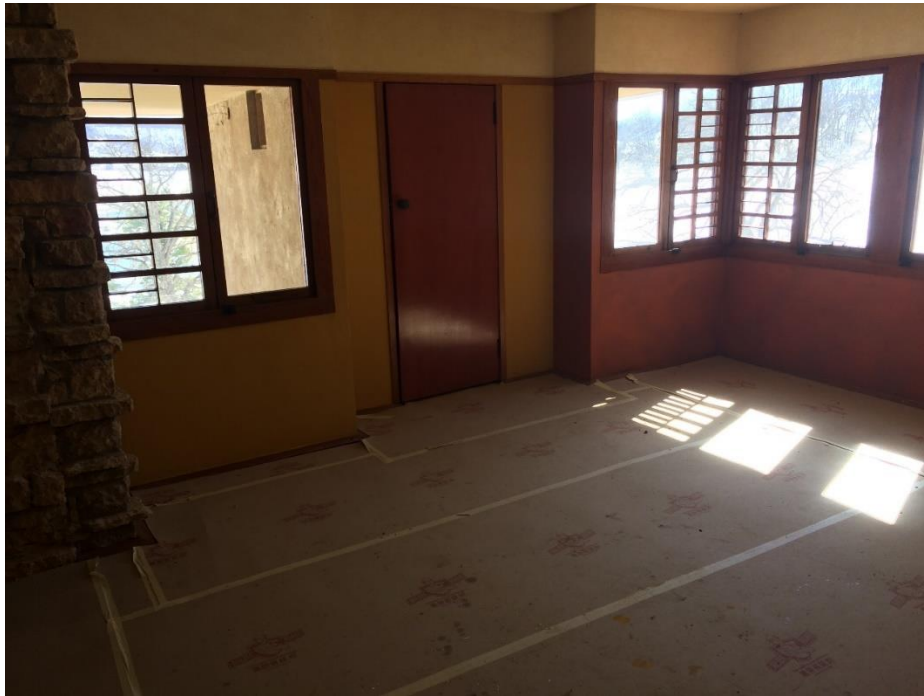
Figure 73. Gold Room, rehabilitation in progress, looking south. Note this rehabilitation is almost complete. The room's new cedar floors are covered in protective paper, and the room is only missing its new furnishings, which are planned to be replicas or adaptations or Wright-designed future. Rehabilitation should be complete by summer of 2017. Photo by author, 2017.

Below, in the Guest Wing, the preservation team adopted a different approach of rehabilitation instead of restoration. This different treatment reflects a different significance designation and is also contingent on Taliesin's plans for future use. The Gold Room is currently being rehabilitated into private guest quarters, which will not be open to public tours, but can instead house students and visiting scholars (Figure 73, Figure 74). The Guest Wing project is a long-term, comprehensive rehabilitation of this entire floor of the house, comprising stabilization efforts (through underpinning and the addition of concrete and steel), new appliances, flooring, plaster, lighting, plumbing, as well as electrical and mechanical equipment serving the rest of the residence. Historic material in the Guest Wing, where still extant (remember, this area of the house was continuously modified through the 1980s) was deemed largely

unsalvageable because of water infiltration and mold. Additionally, aligning with the significance designation, the preservation plan lays out guidelines to preserve the layout and interior appearances of these spaces to the degree possible as secondarily significant spaces, as opposed to stronger material reverence in the spaces of primary significance above. As such, the team used historic photographs to design a new condition that seeks to reflect the color, layout, and trim work of the historic rooms, while still creating a hospitable environment for guests including modern bathrooms and appliances.

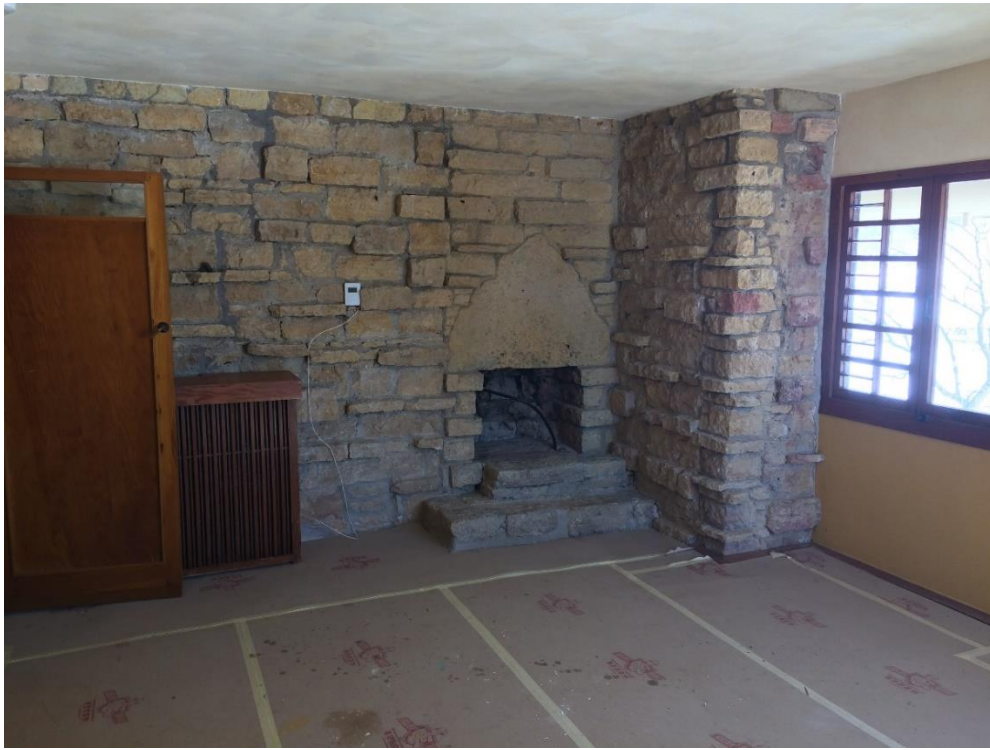
Figure 74. Gold Room, rehabilitation in progress, looking northeast, including restored fireplace and researched radiator grilles, photo by author, 2017.
